BASSETT UNIFIED SCHOOL DISTRICT

SCHOOL SITE

CONDITIONS ASSESSMENT

Assessment Summary

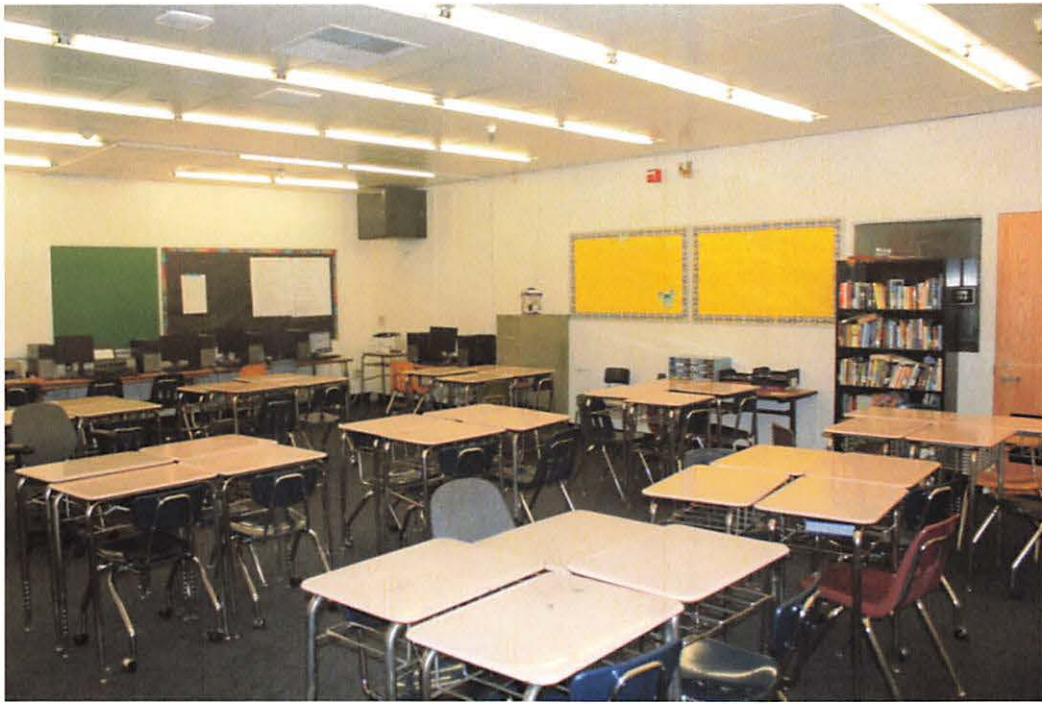
Typical Classroom - finishes look worn and outdated

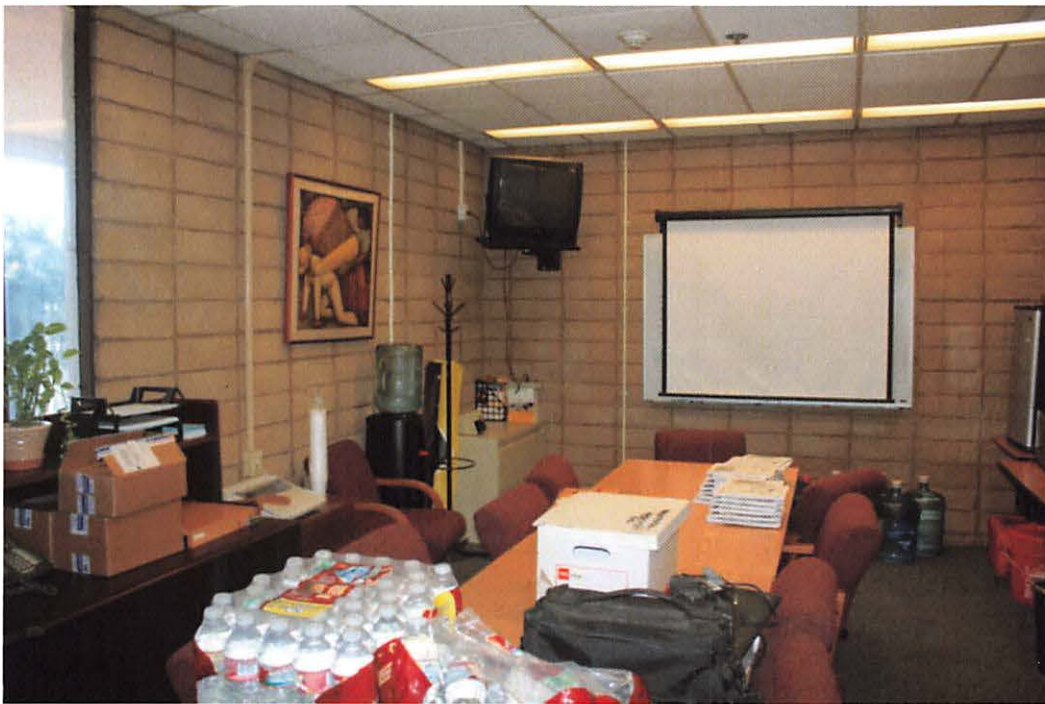
Staff Lounge - looks very dull, in need of storage

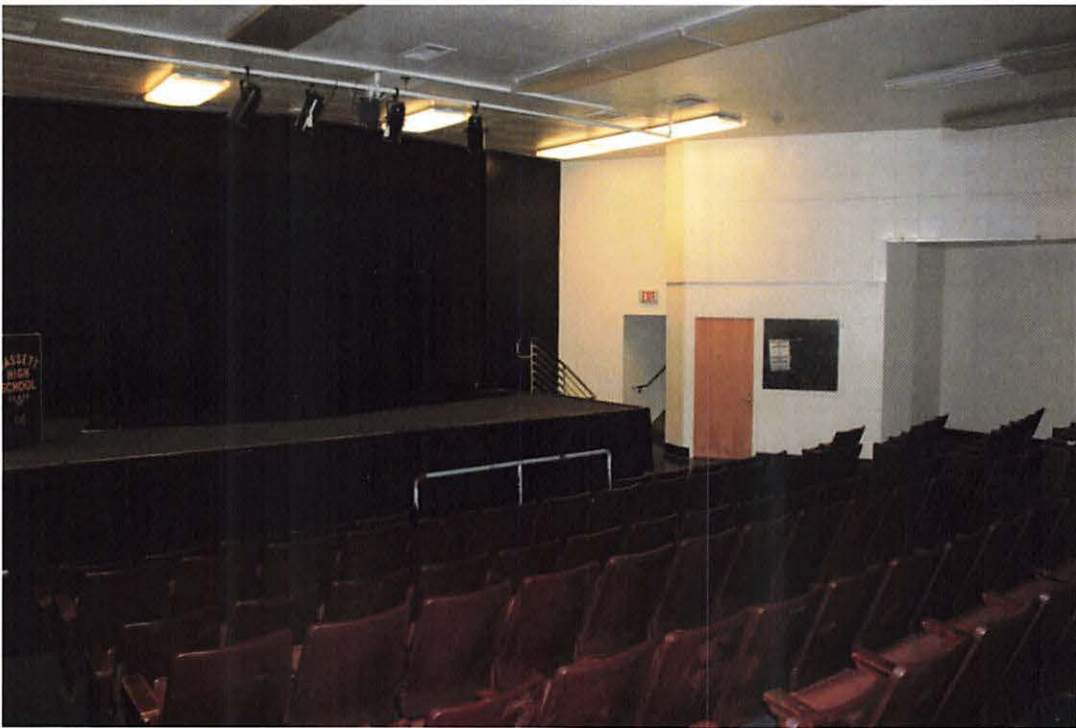
Theatre – Does not meet current Accessibility requirements

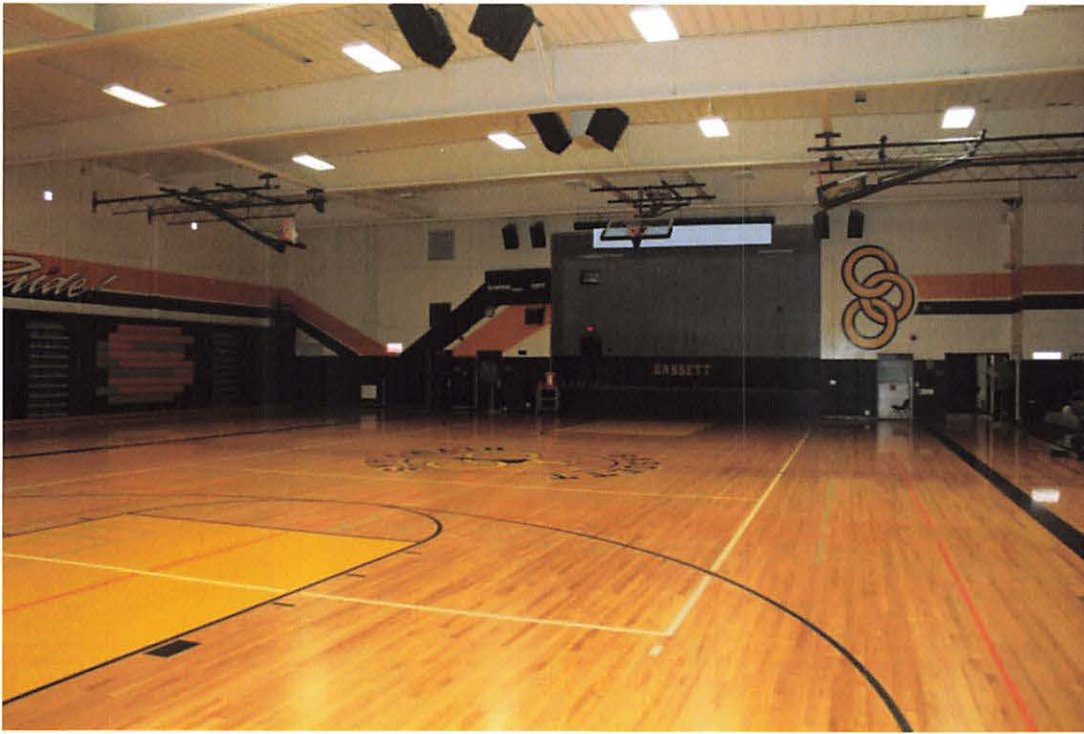
Gymnasium – Looks recently updated recommend providing more natural lighting

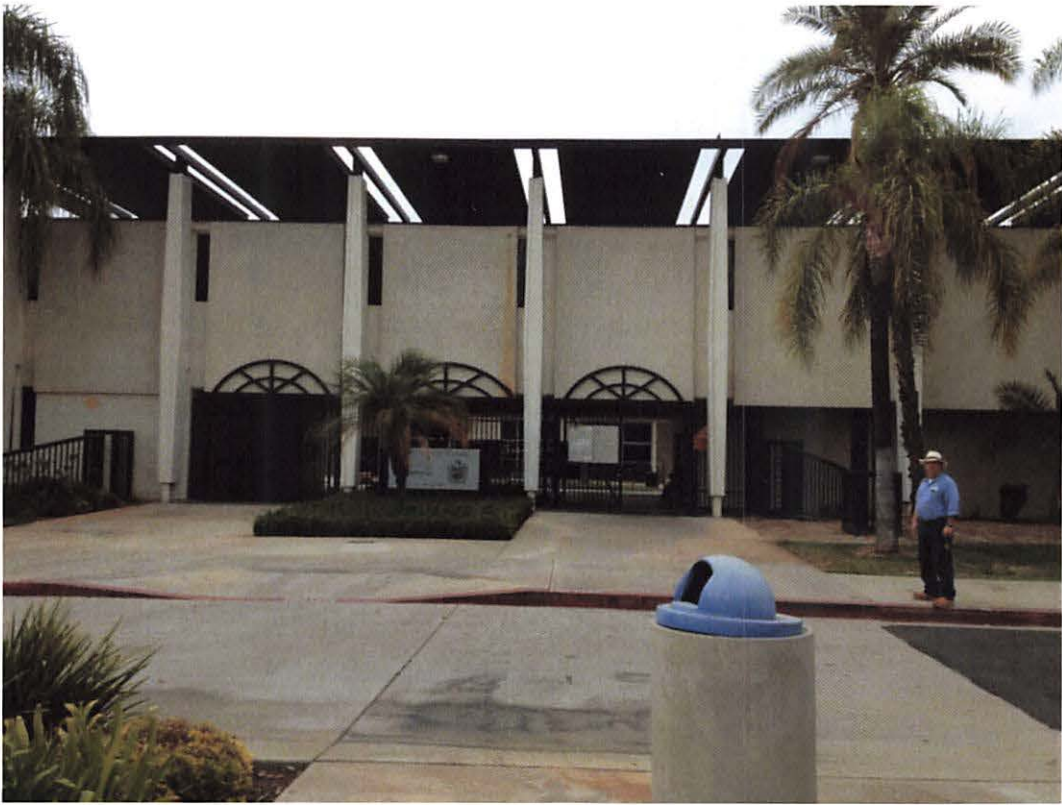
Exterior façade need updating

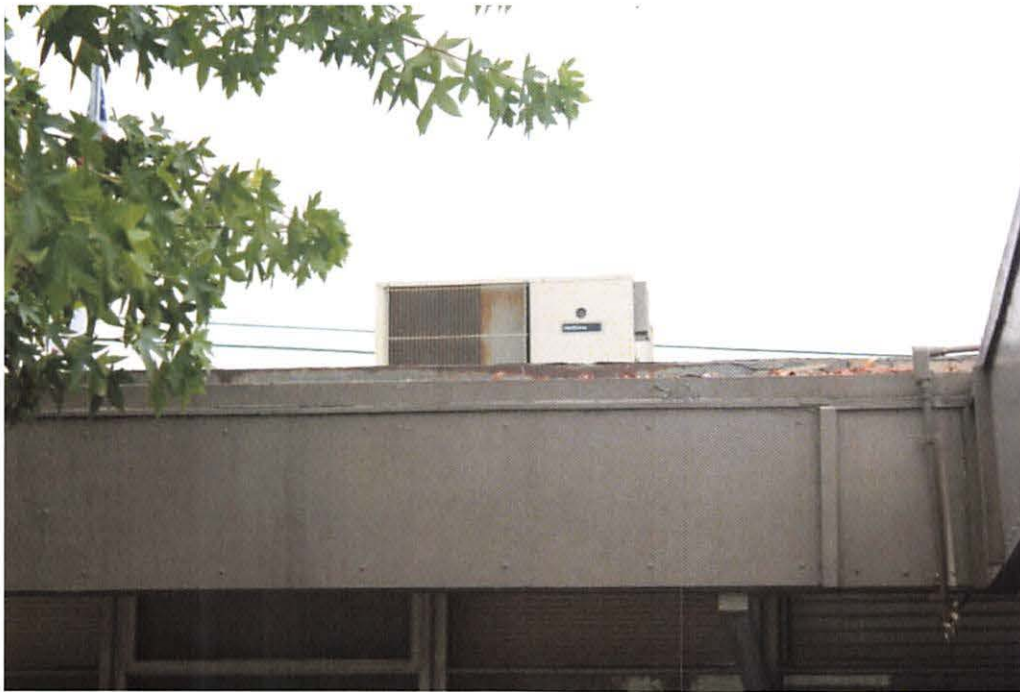
Roof Damage – needs to be repaired/replaced

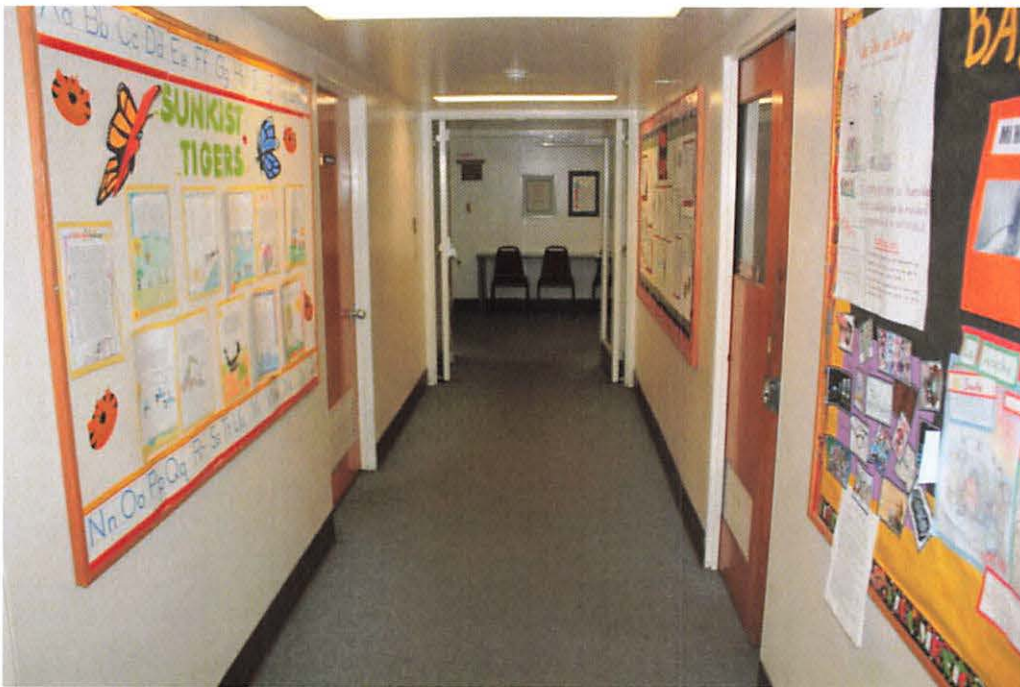
Corridors - Ceilings are extremely low with no natural lighting

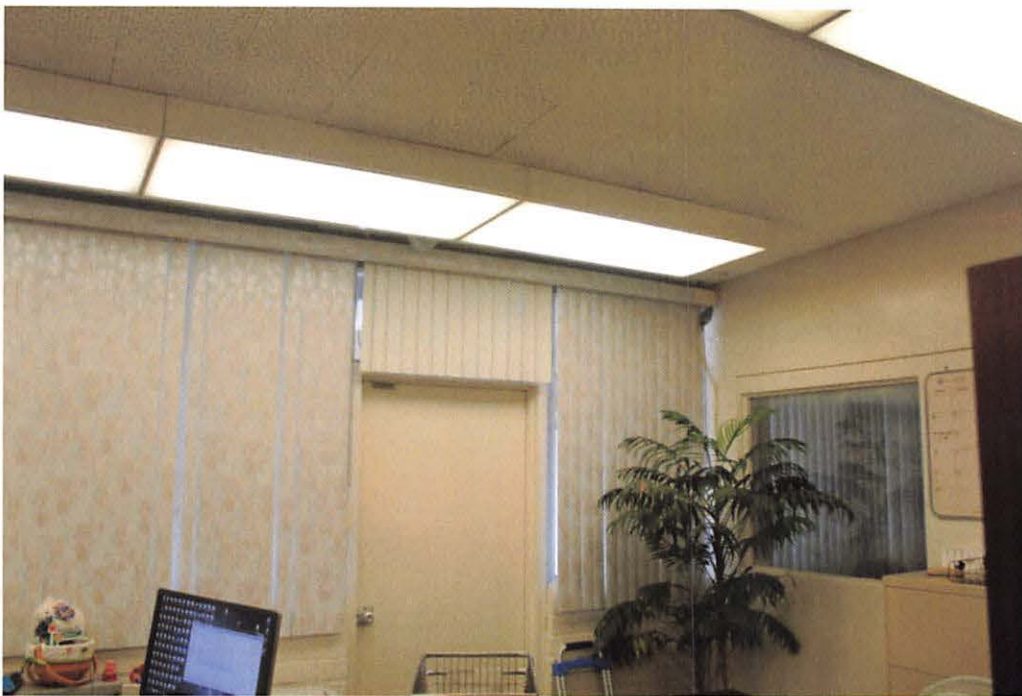
Office - Ceilings and lighting is old, needs upgrade

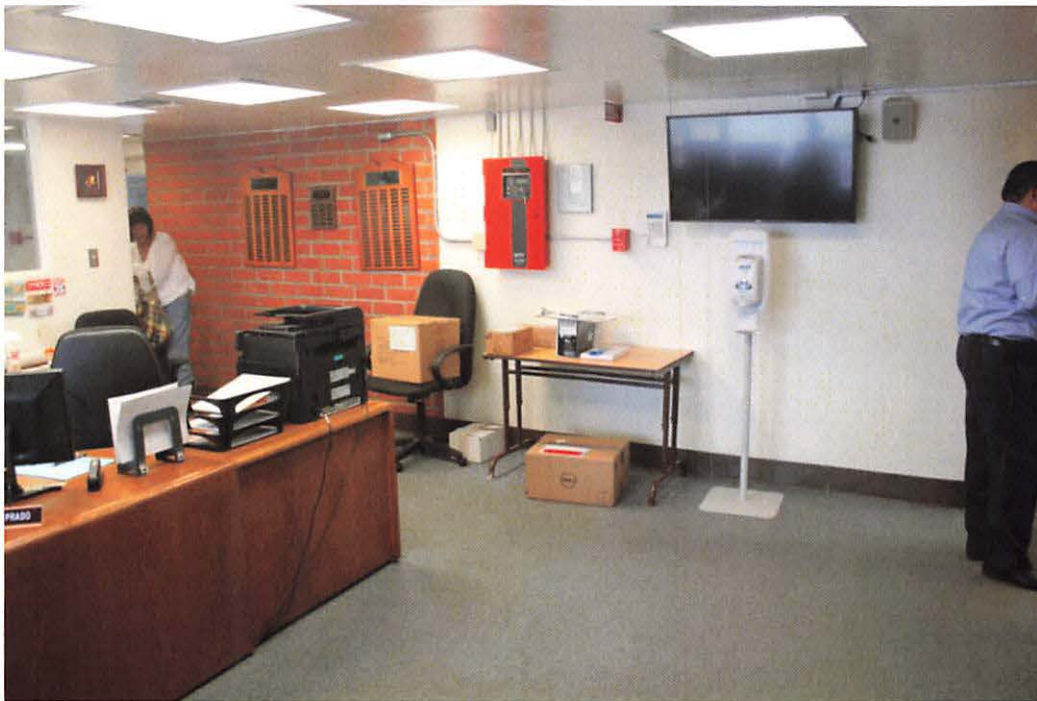
Reception - Casework is outdated, more storage options needed

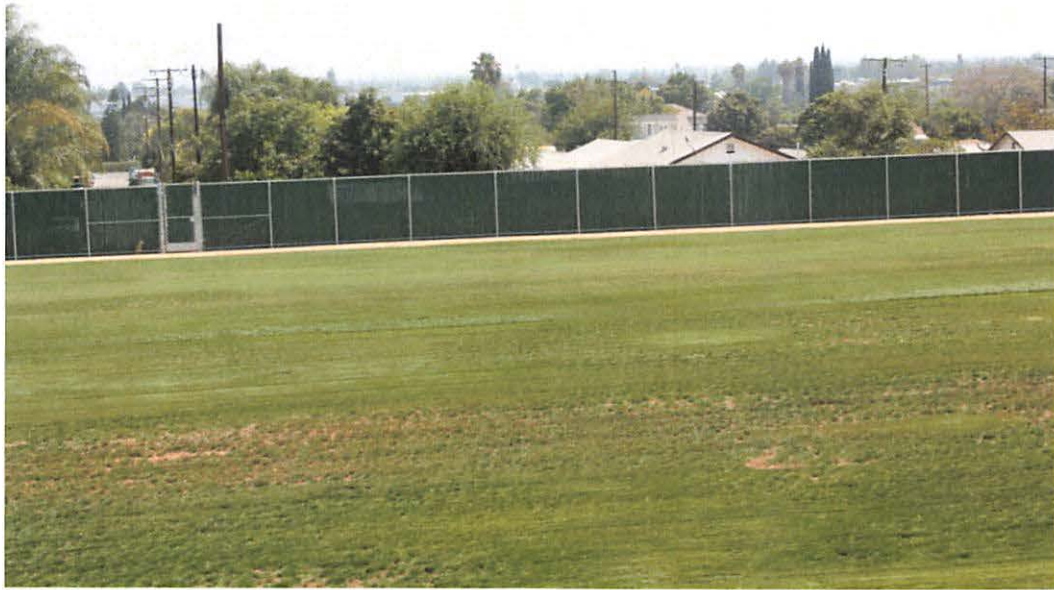
Field - Recommend artificial turfing

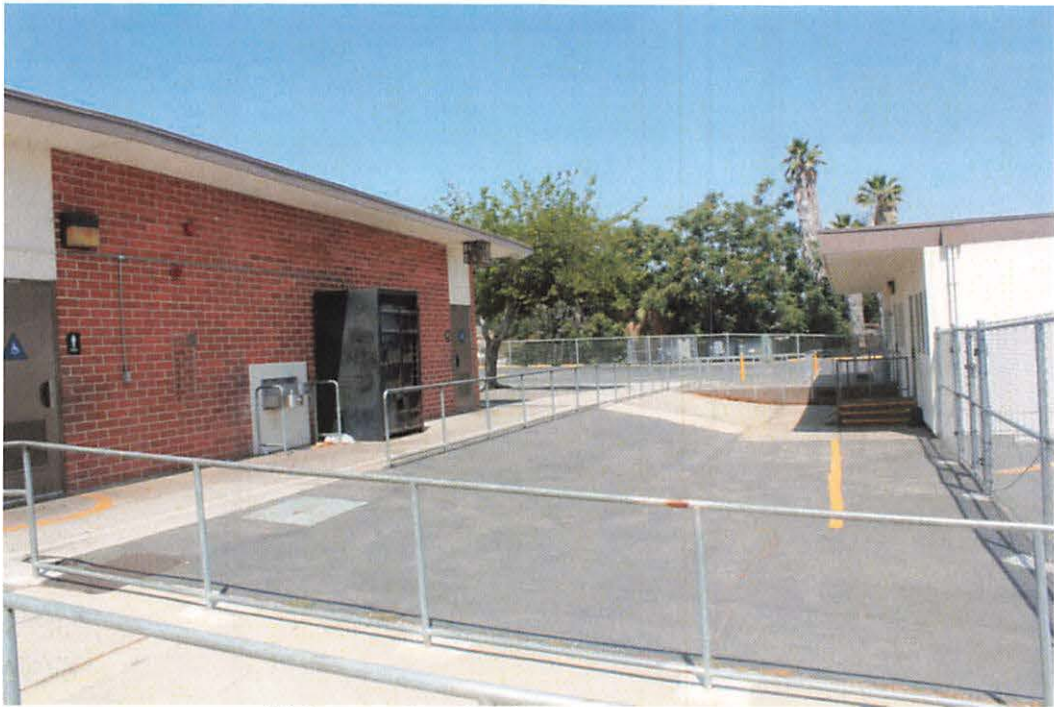
Walkway - Grading in path of travel more than 2%

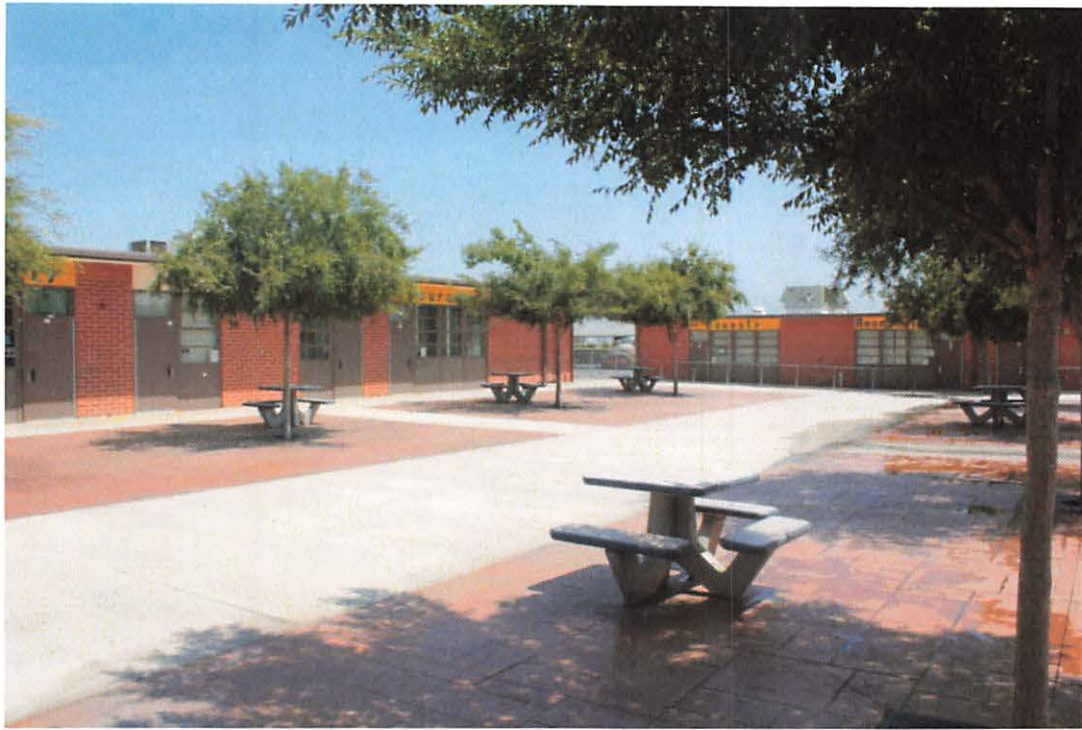
Outdoor learning areas have been recently upgraded, however could be better utilized

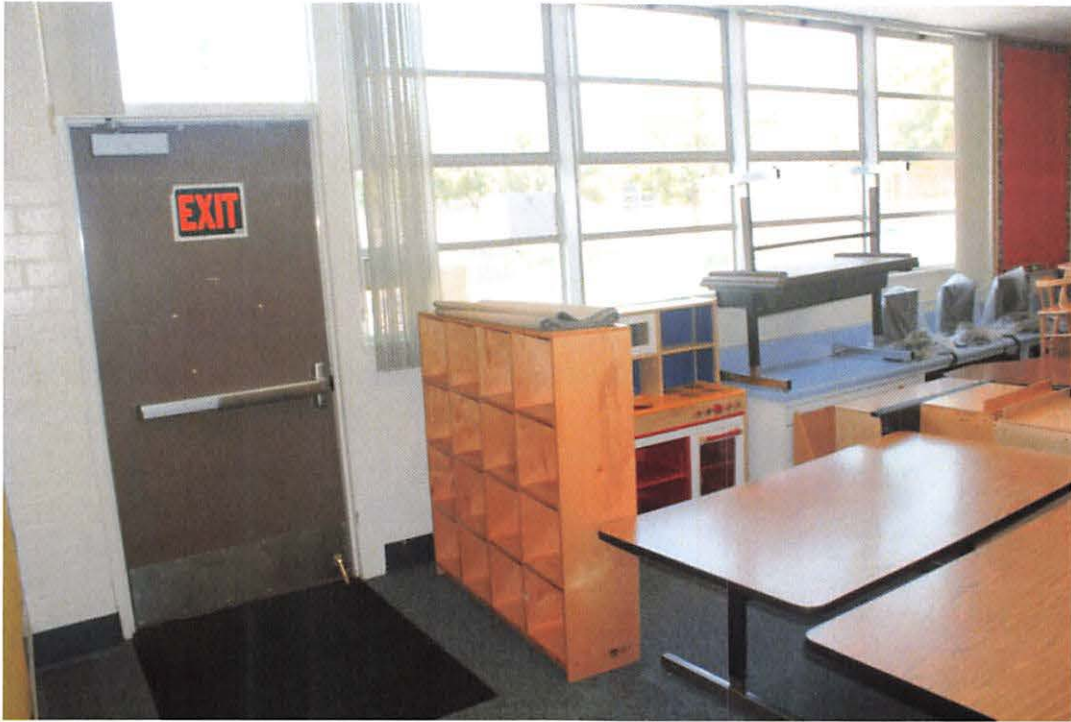
Signage to be updated per DSA requirements

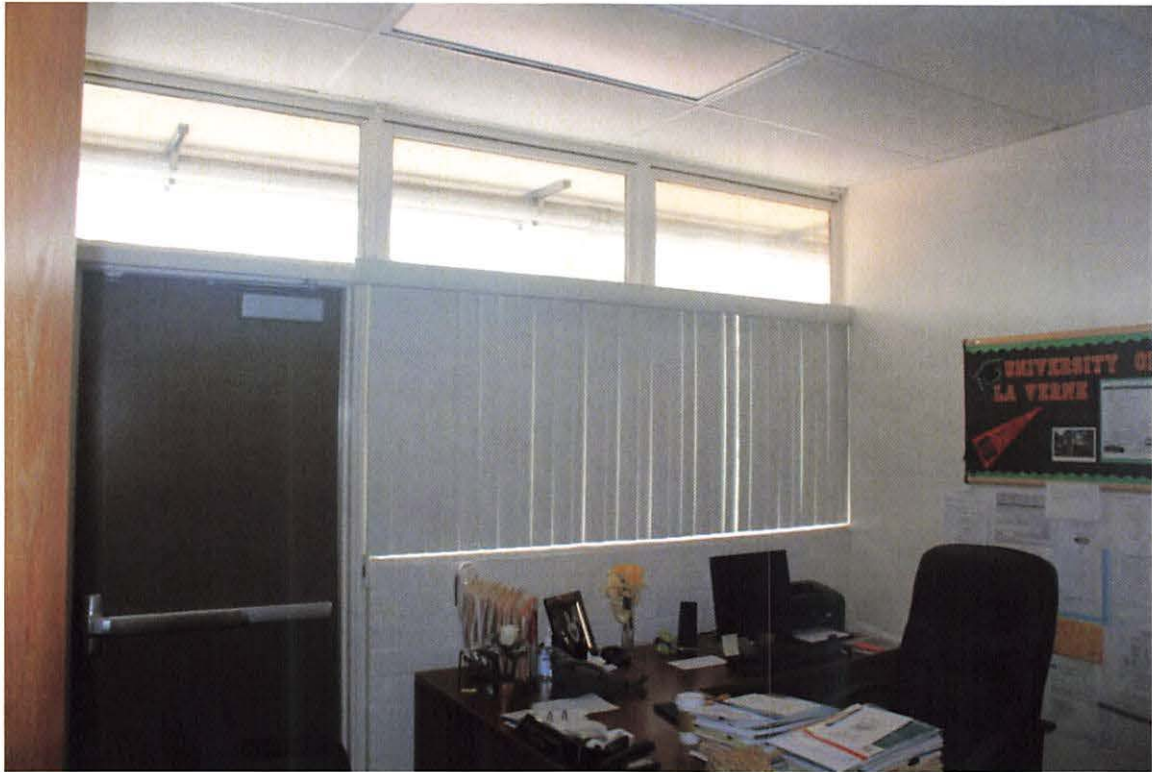
Office – finishes are outdated, needs storage and casework solutions

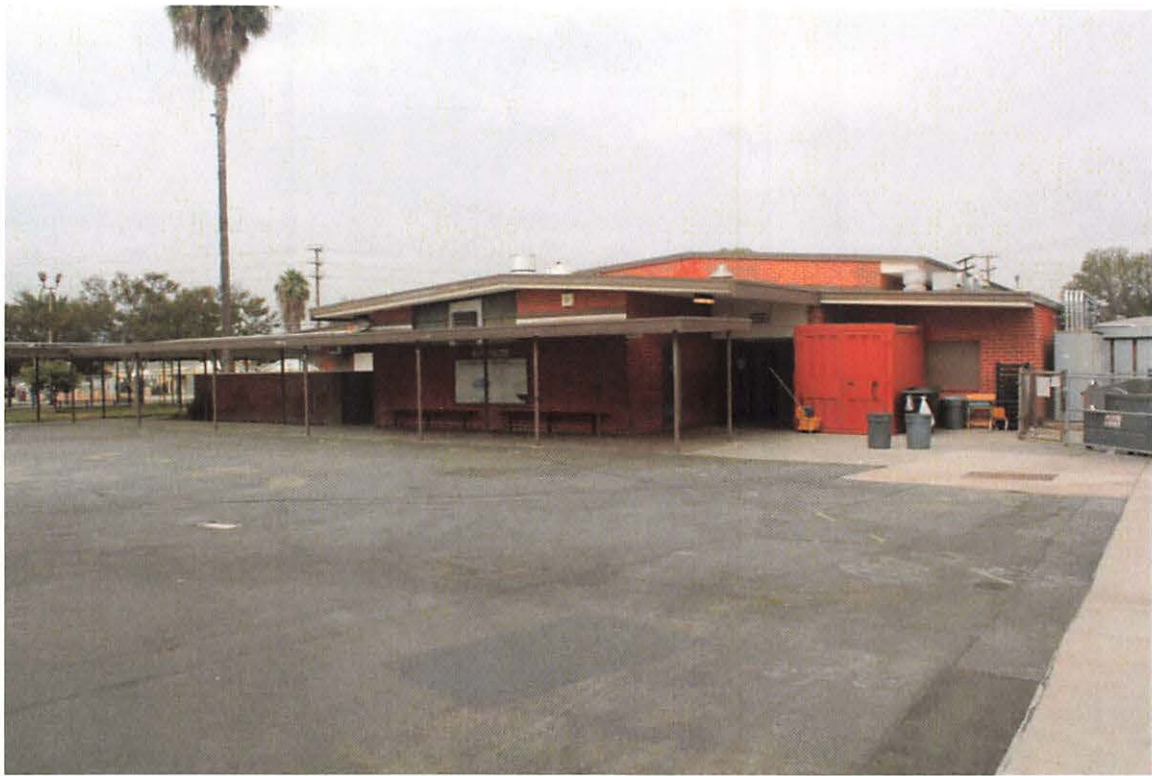
Outdoor Commons can be better utilized

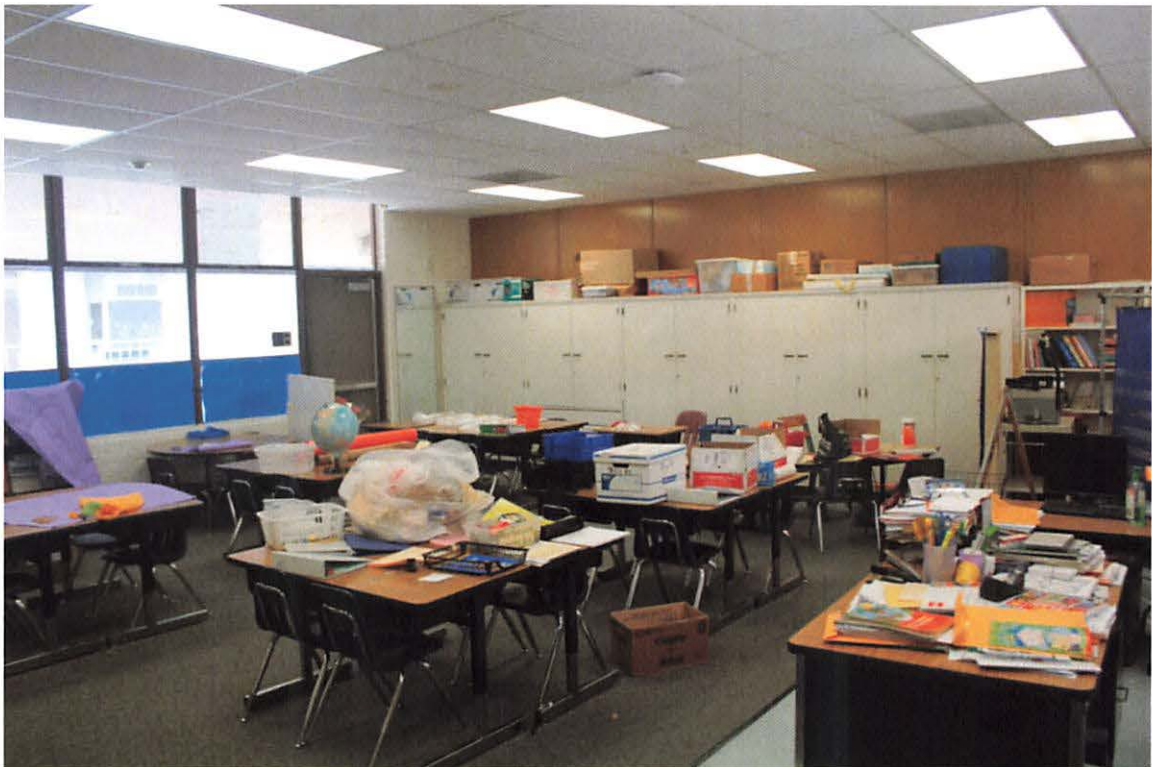
Typical Classroom – furniture and finishes outdated, need storage

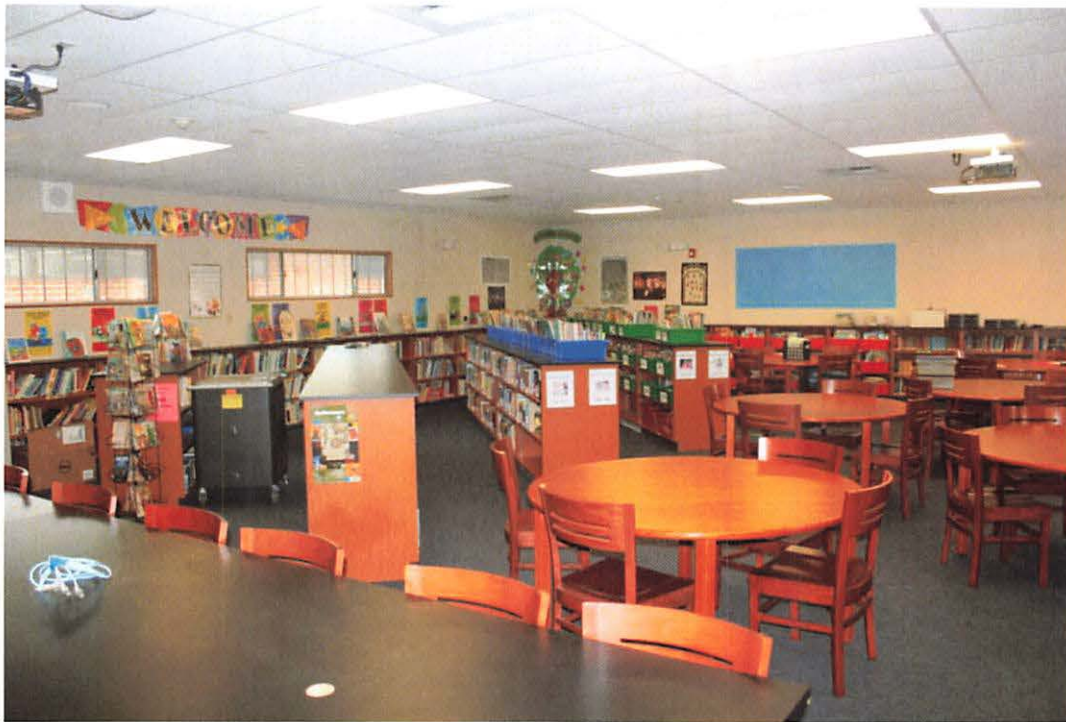
Library – finishes outdated, environment is dull

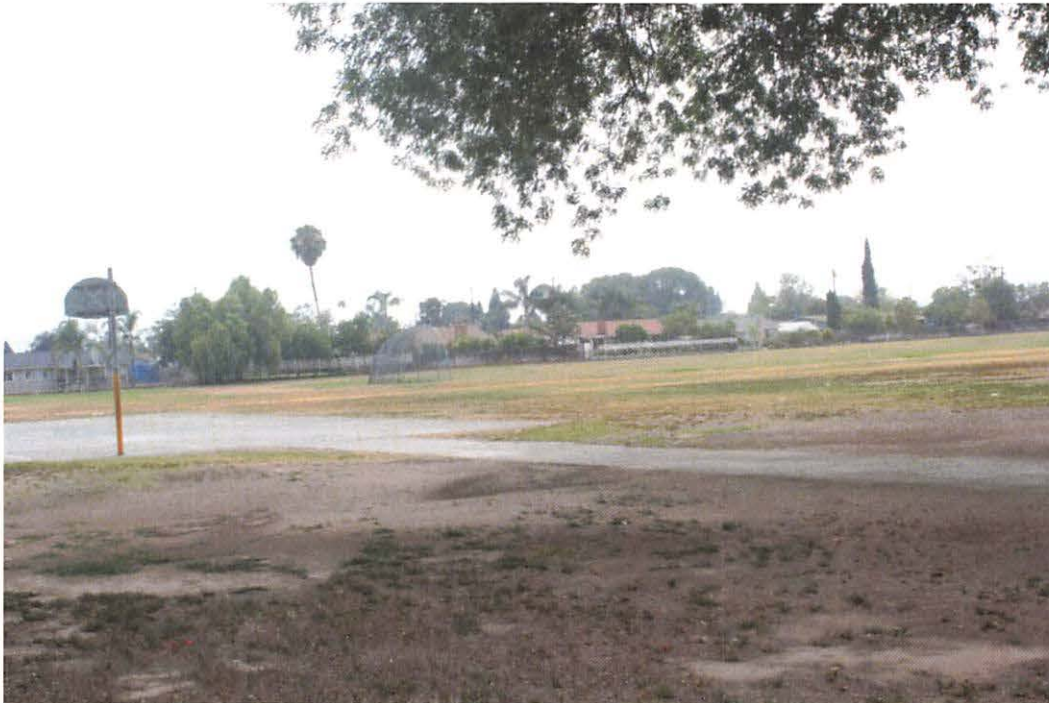
Field - Recommend artificial turfing and reseeding

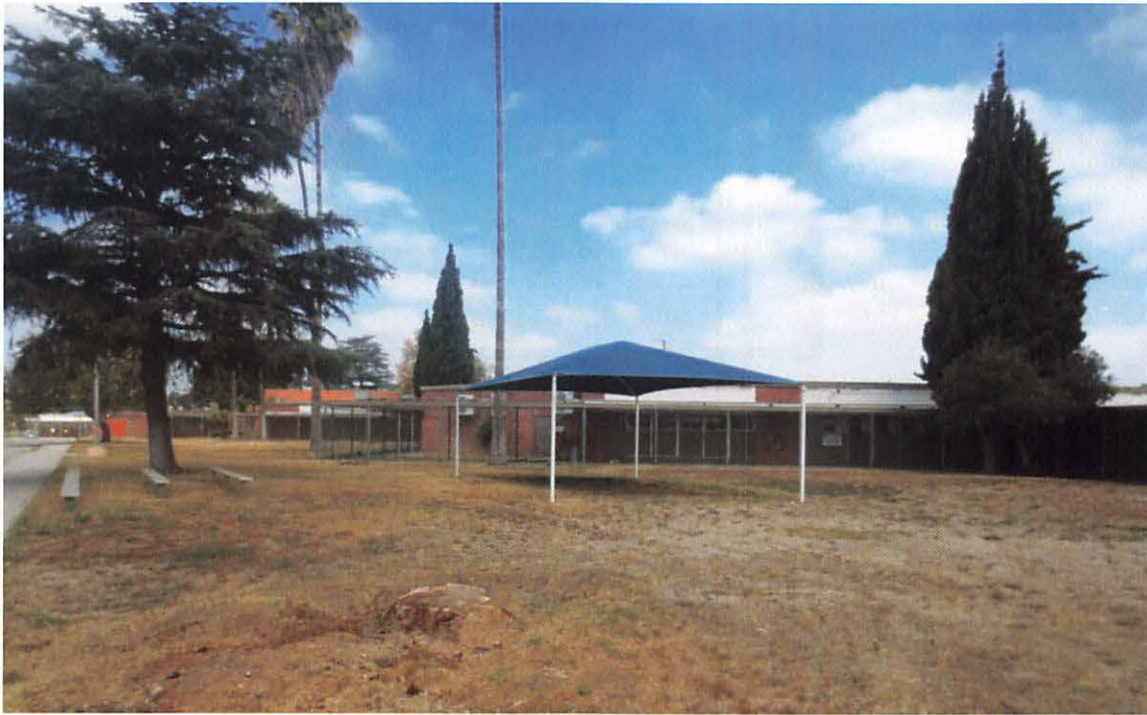
Outdoor areas need to be reseeded

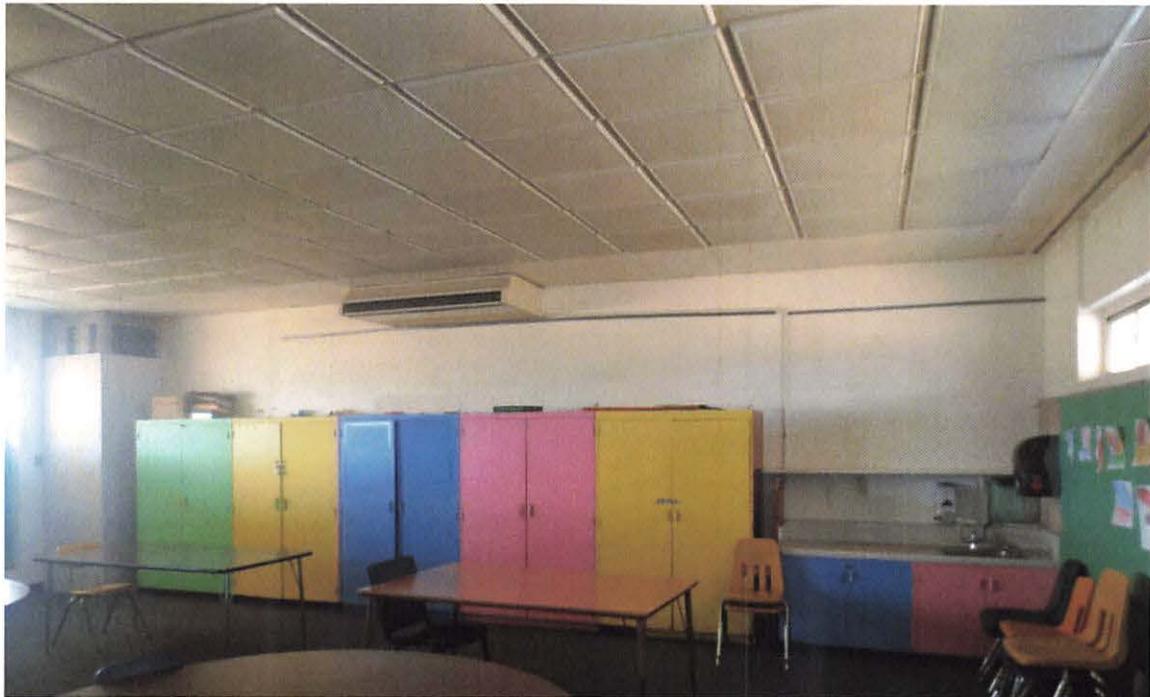
Casework and finishes need updating

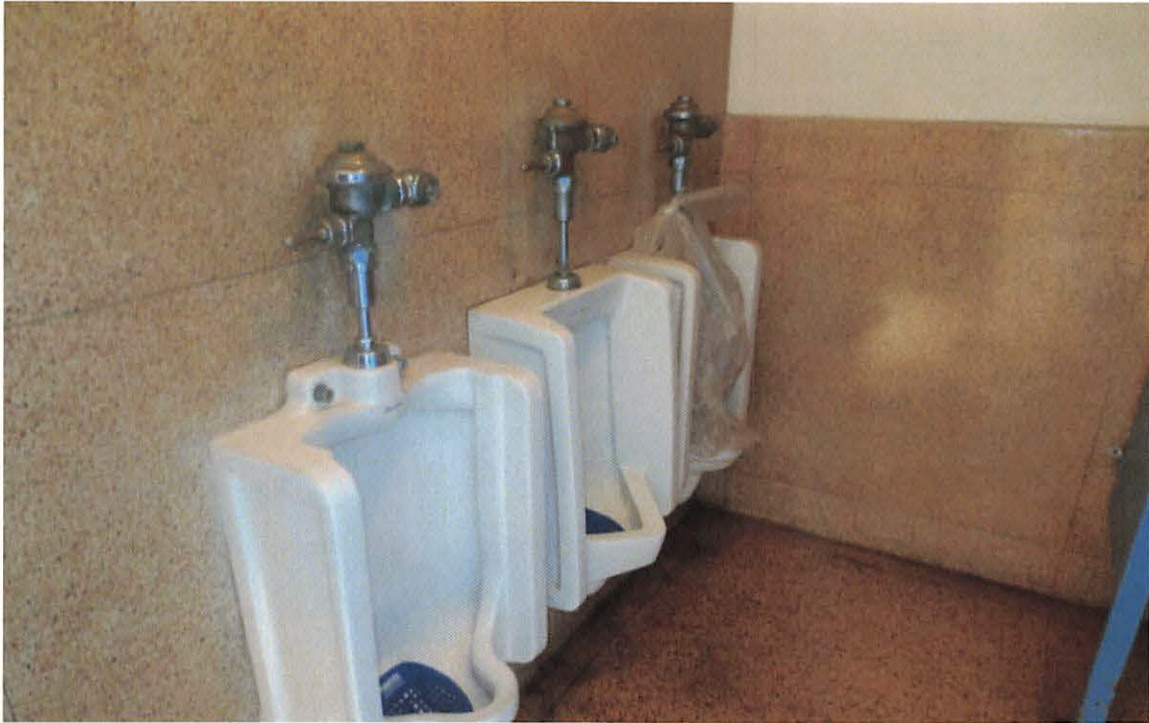
Toilet facilities need updating

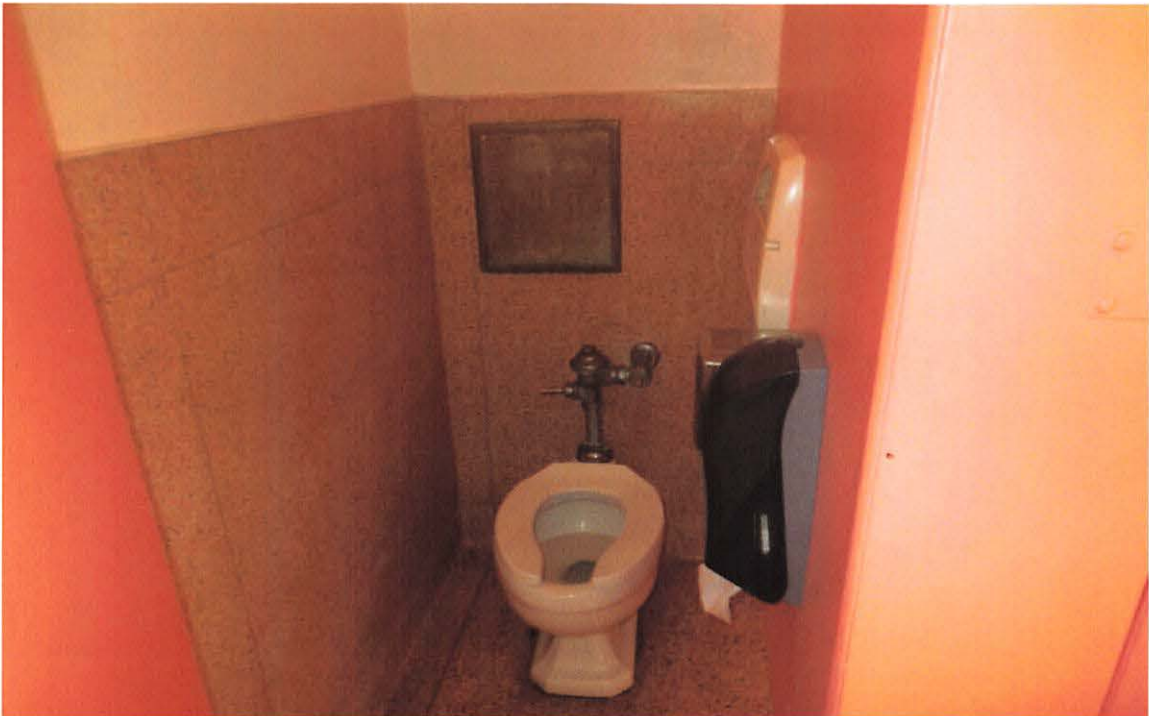
Toilet facilities are not ADA compliant

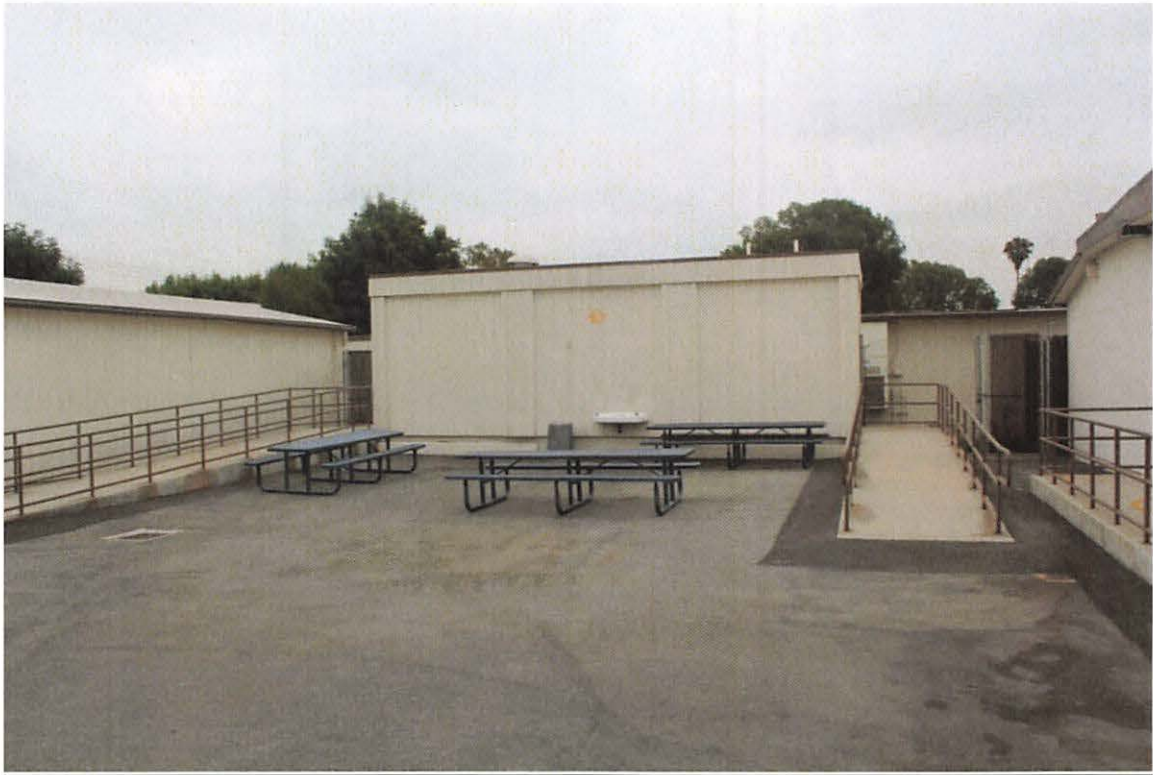
Sitting Area – needs to be updated to a outdoor learning commons

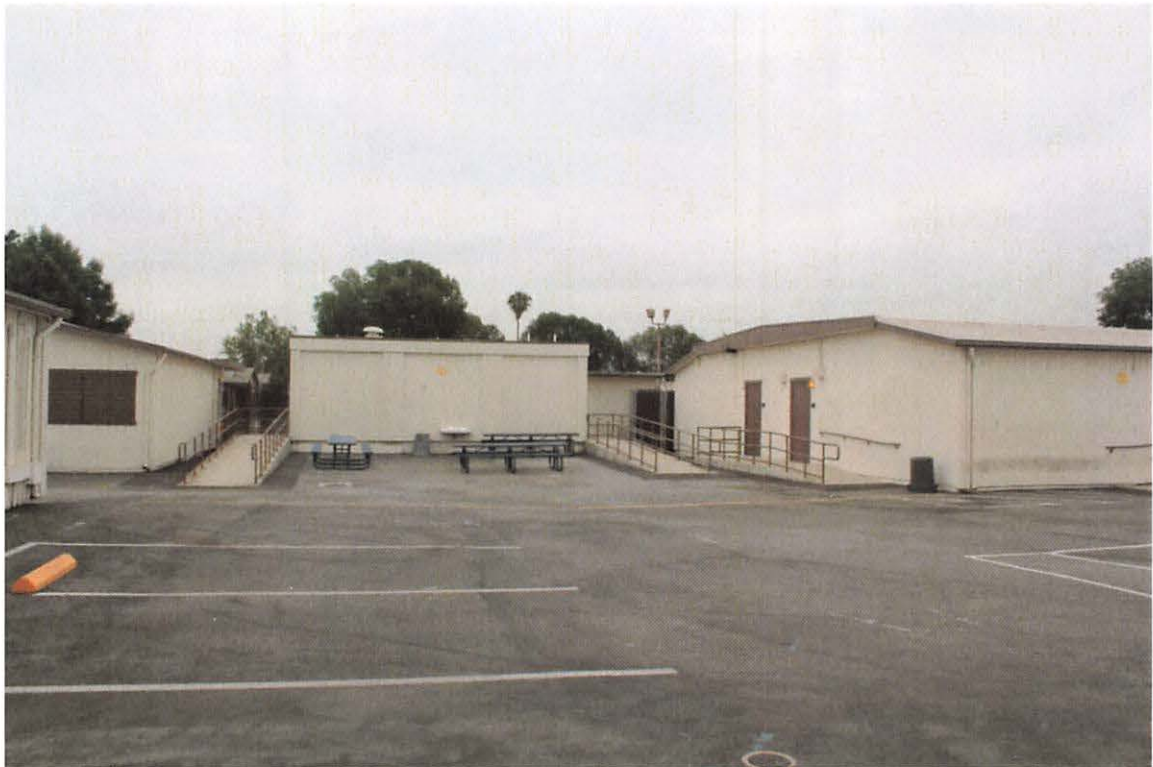
Exterior Buildings – needs updating and paint

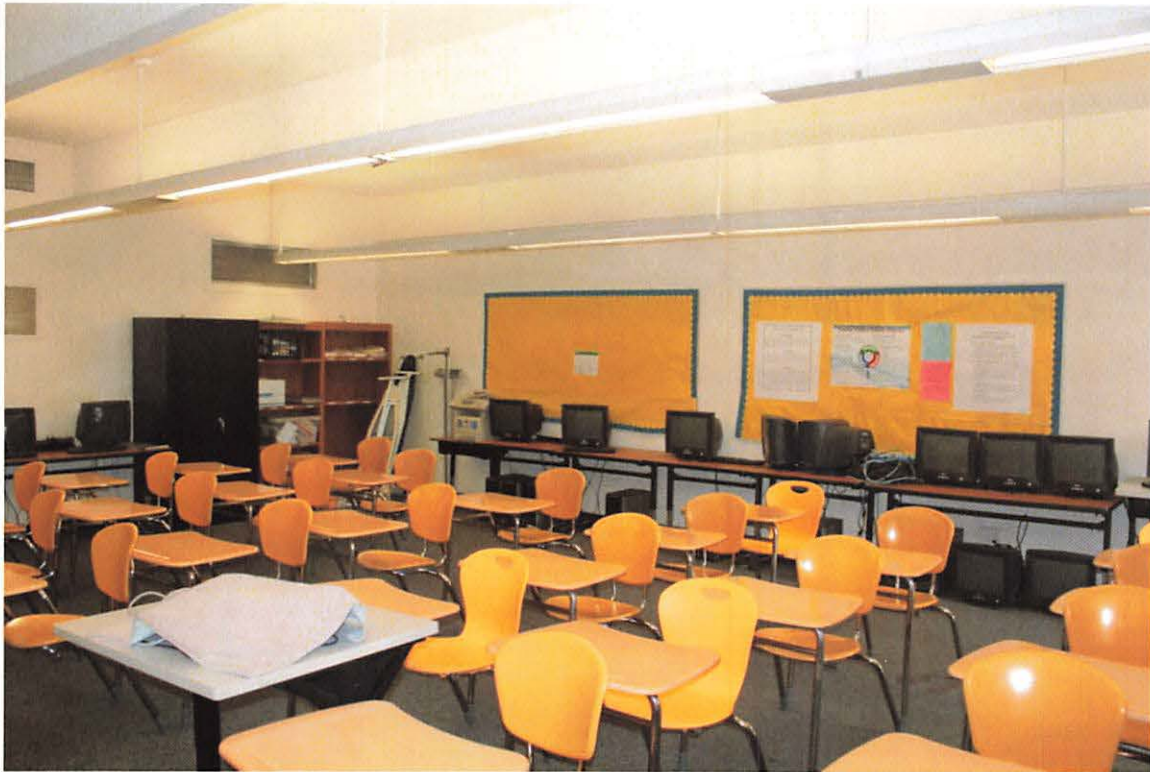
Typical Classroom – outdated, needs new finishes, natural light storage & casework

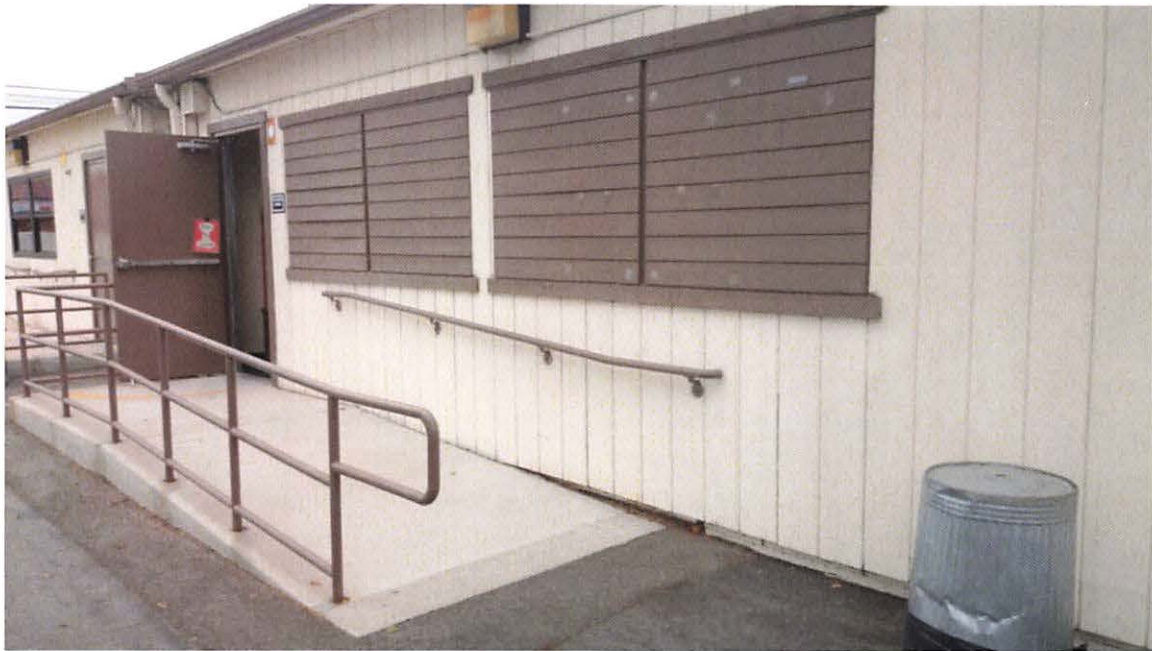
Natural light is needed in the classrooms

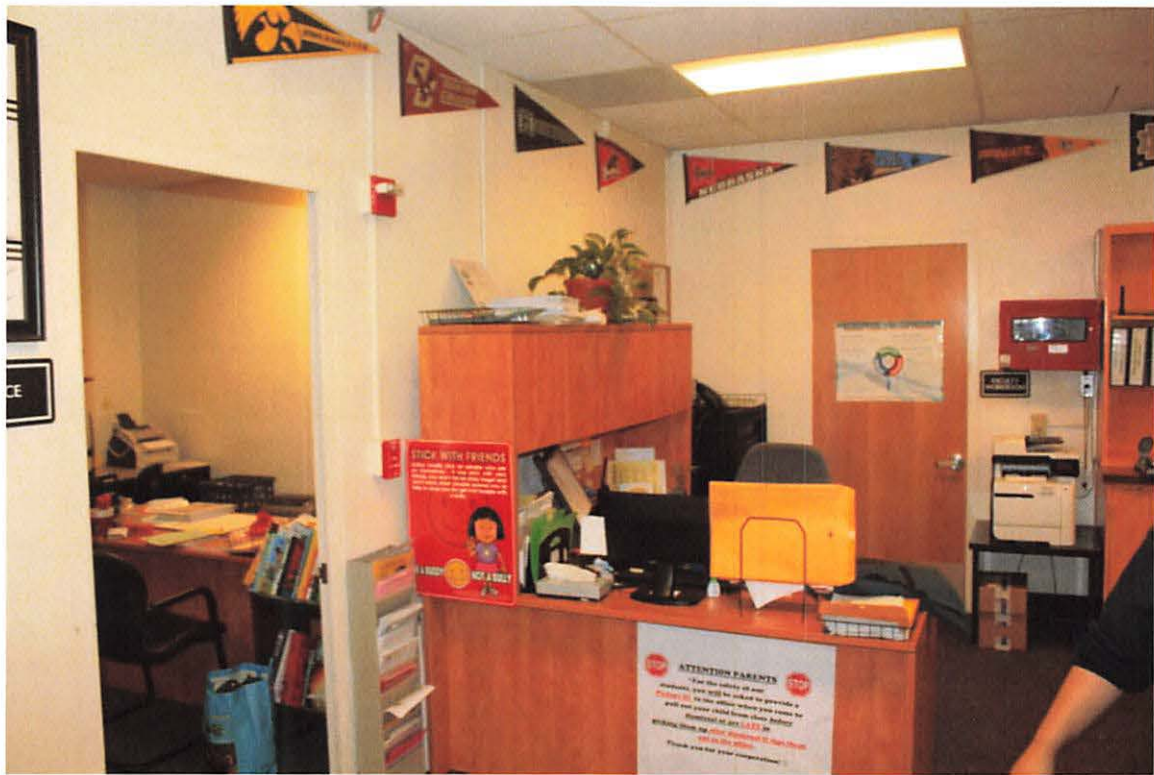
Office – finishes are outdated, needs storage and casework

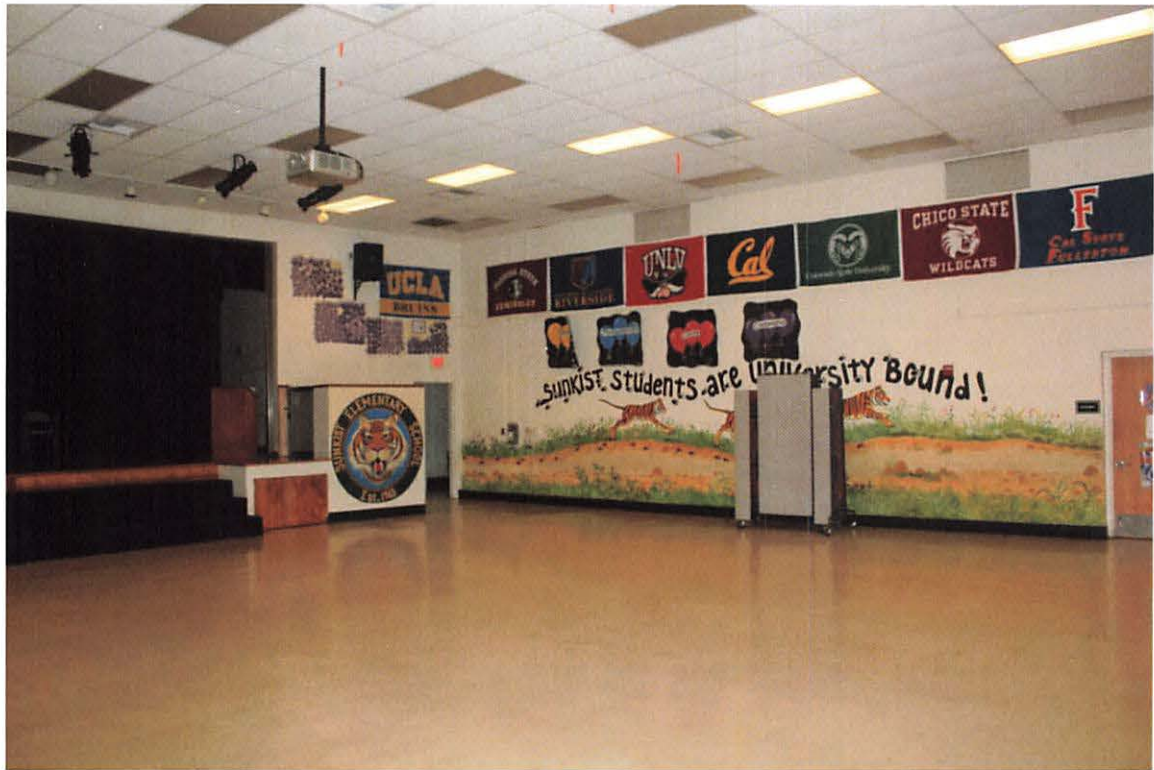
Multi-Purpose & Stage – finishes outdated
