BASSETT UNIFIED SCHOOL DISTRICT

SCHOOL SITE

CONDITIONS ASSESSMENT

Assessment Summary

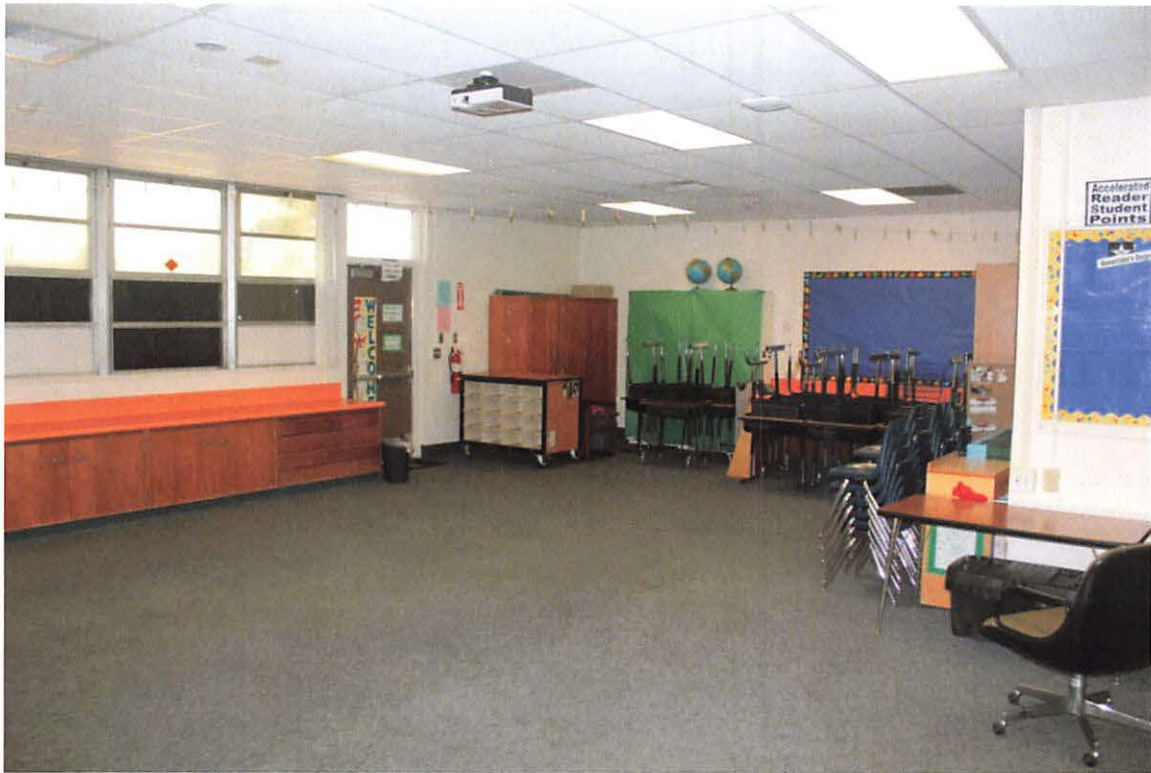
Typical Classroom – Finishes outdated

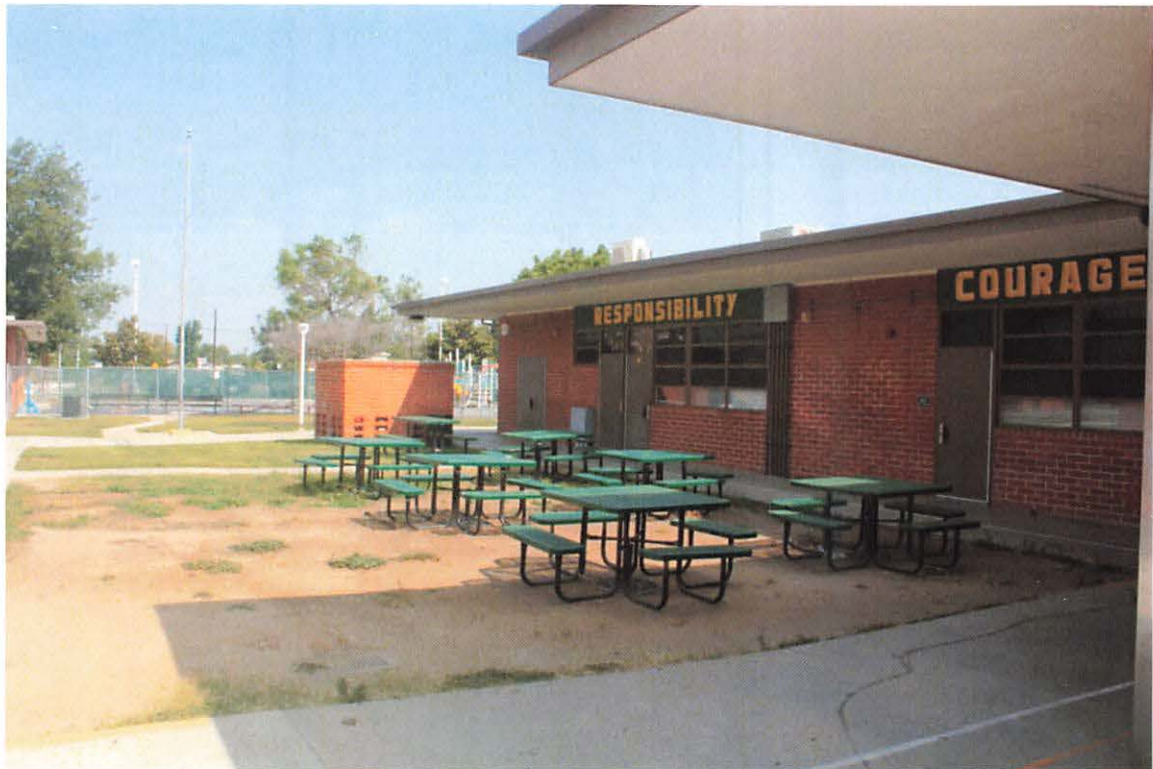
Lunch Area – needs shelter

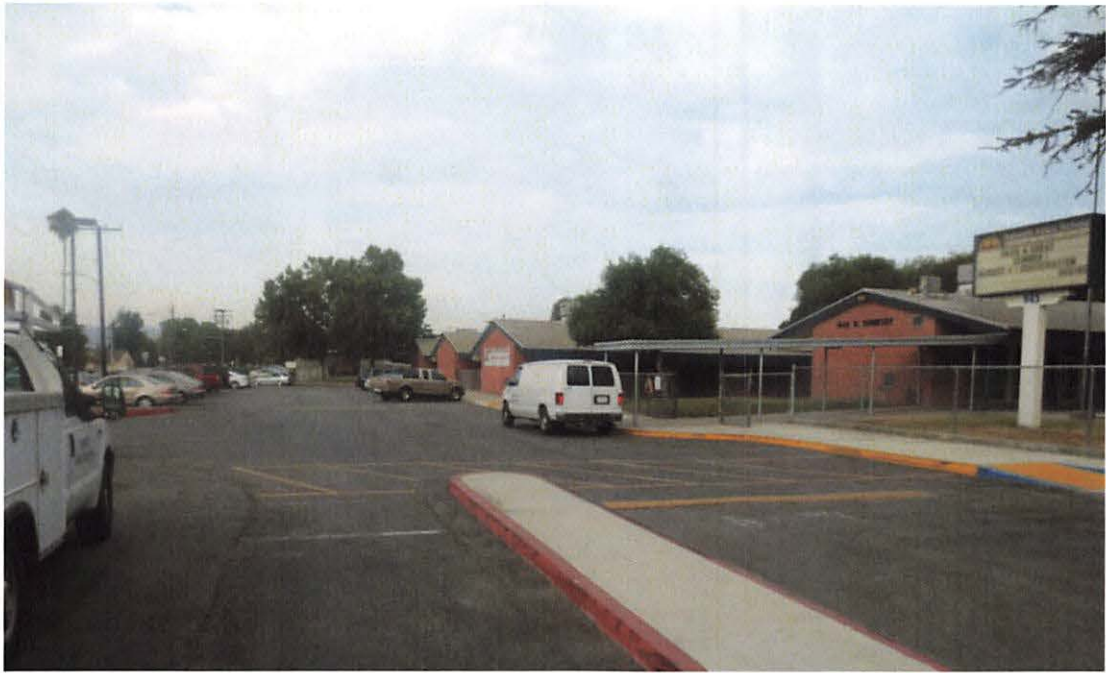
Parking lot requires restriping

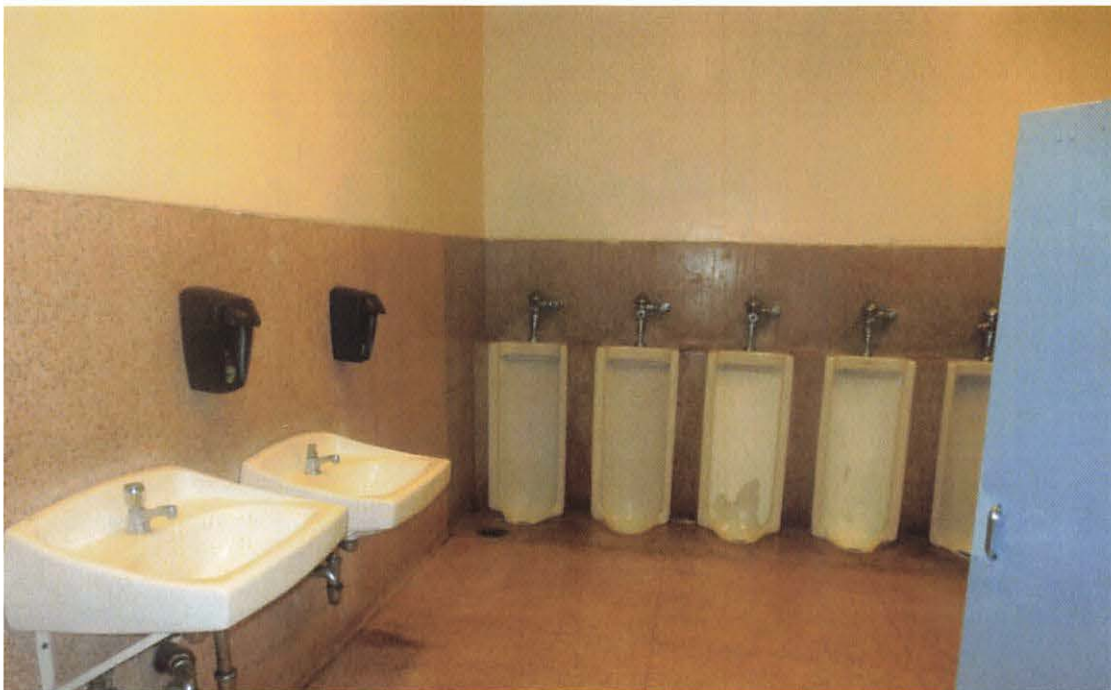
Restrooms require updating to be ADA compliant

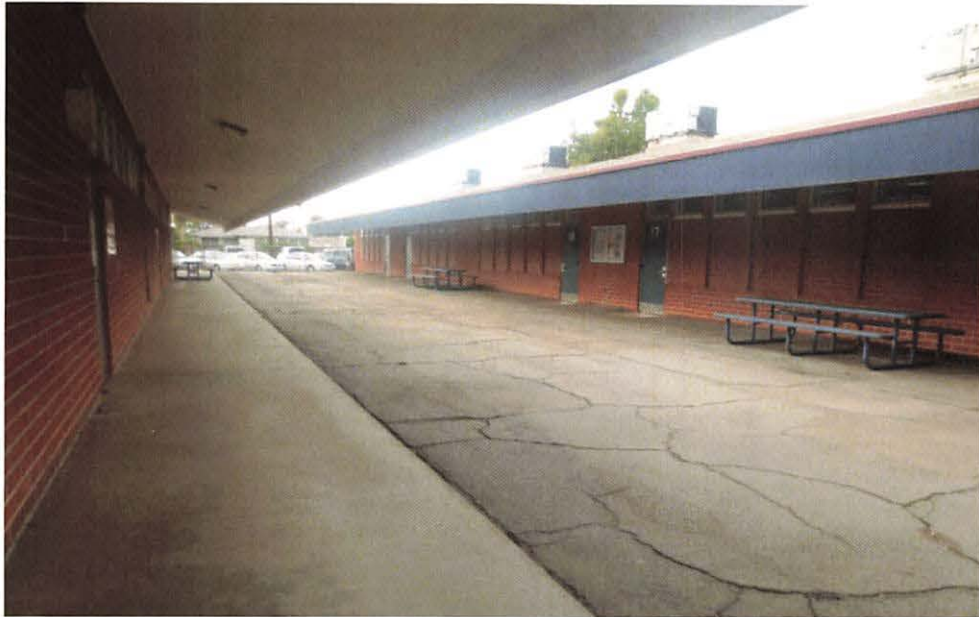
Outdoor areas are not utilized

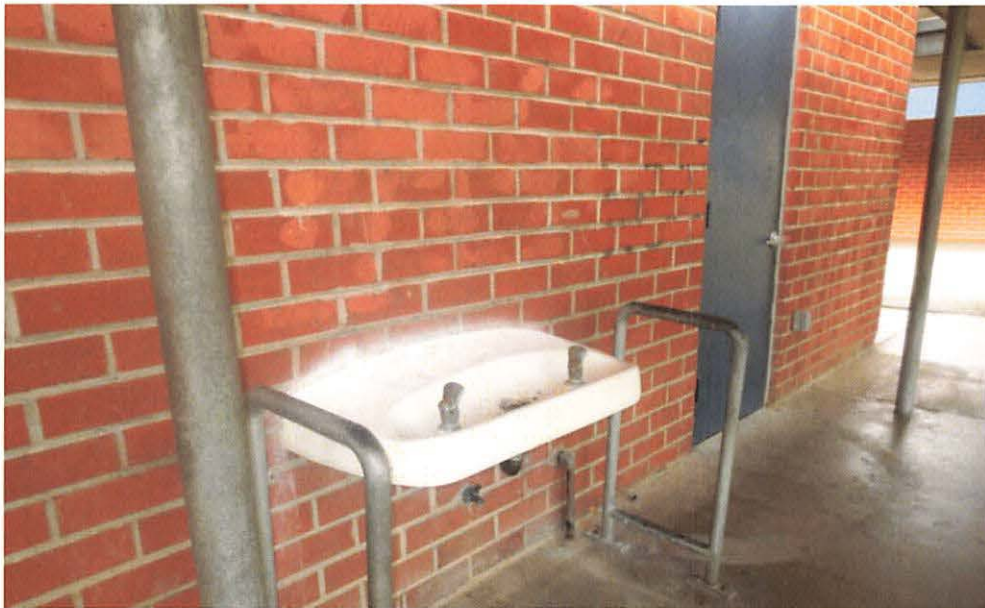
Drinking fountains are not accessible

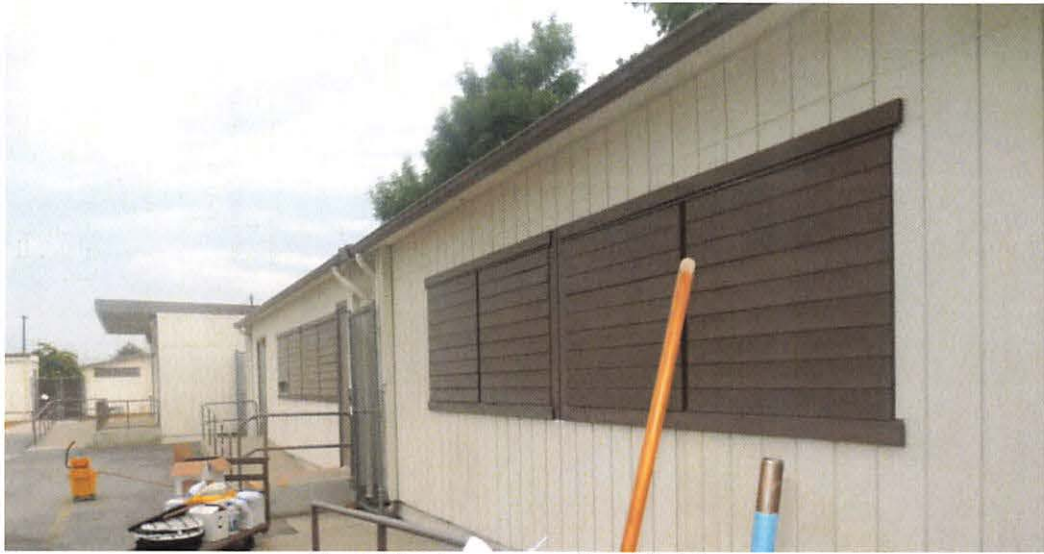
Portables have no natural lighting

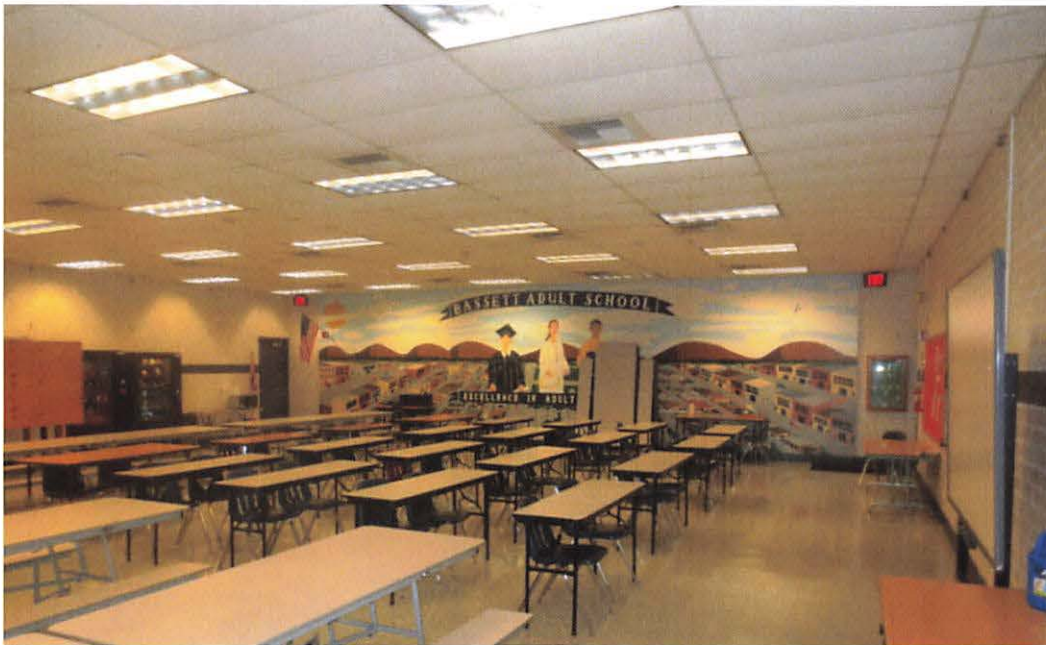
Multi-purpose- finishes need updating

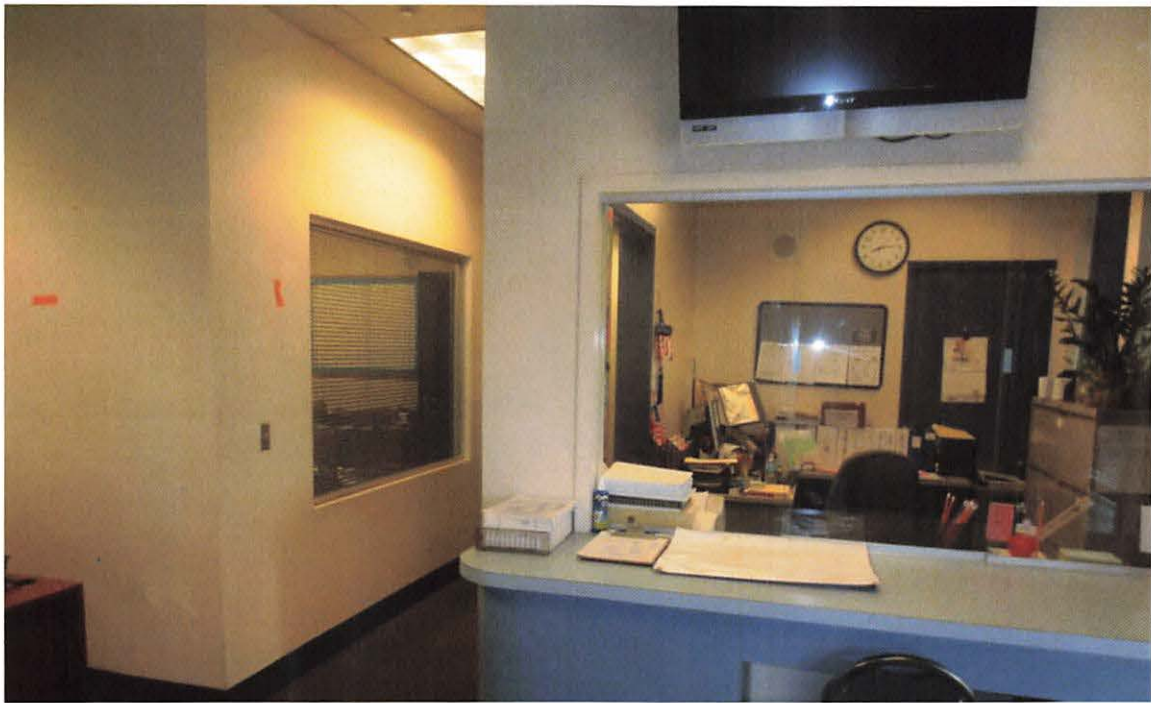
Admin area-finishes need updating

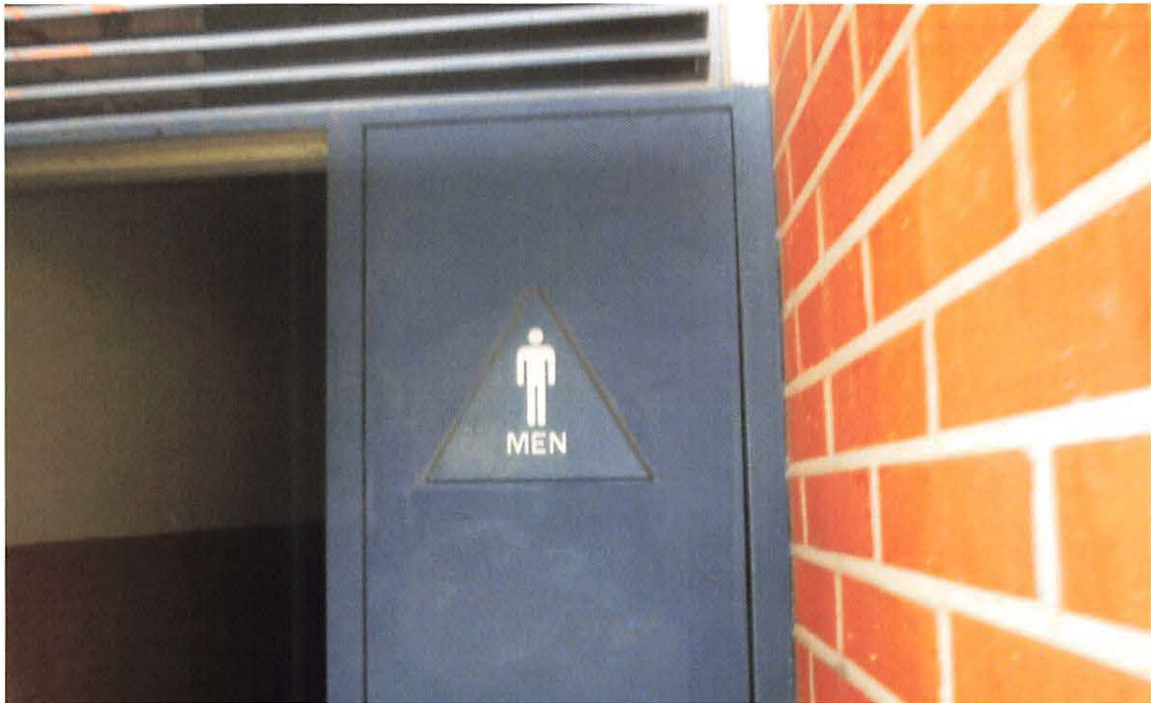
ADA compliant signage required throughout campus

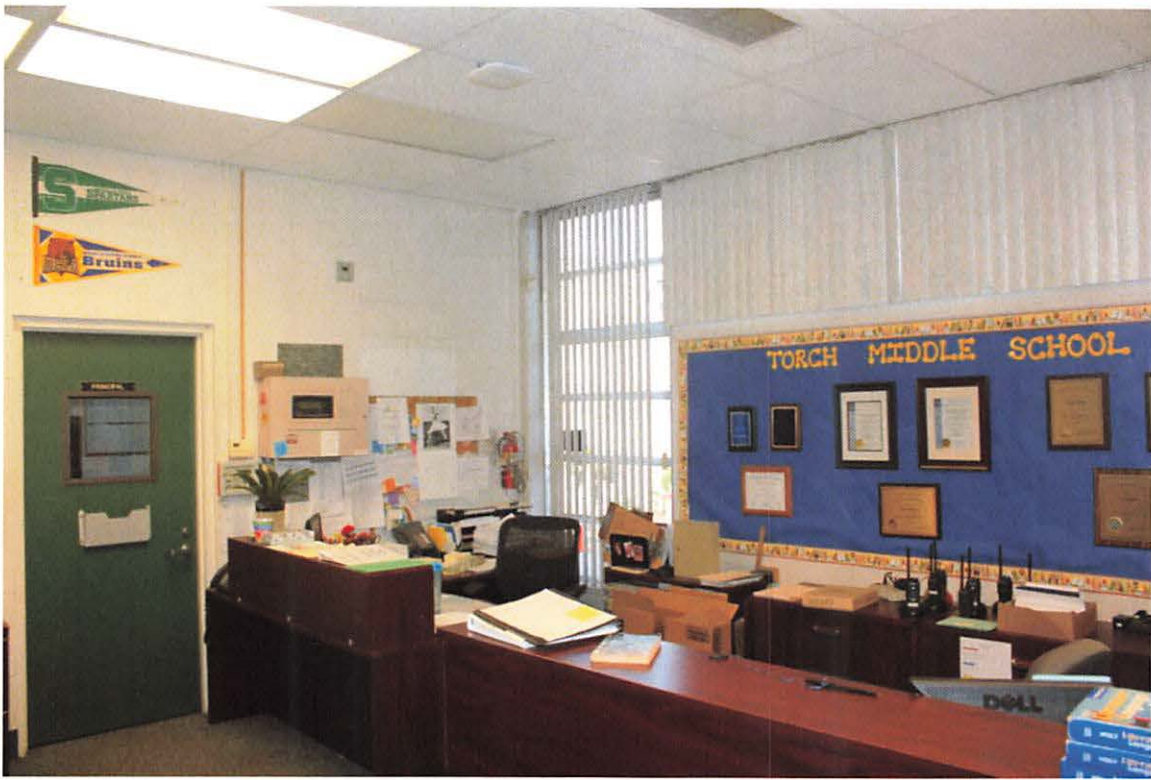
Offices – finishes outdated

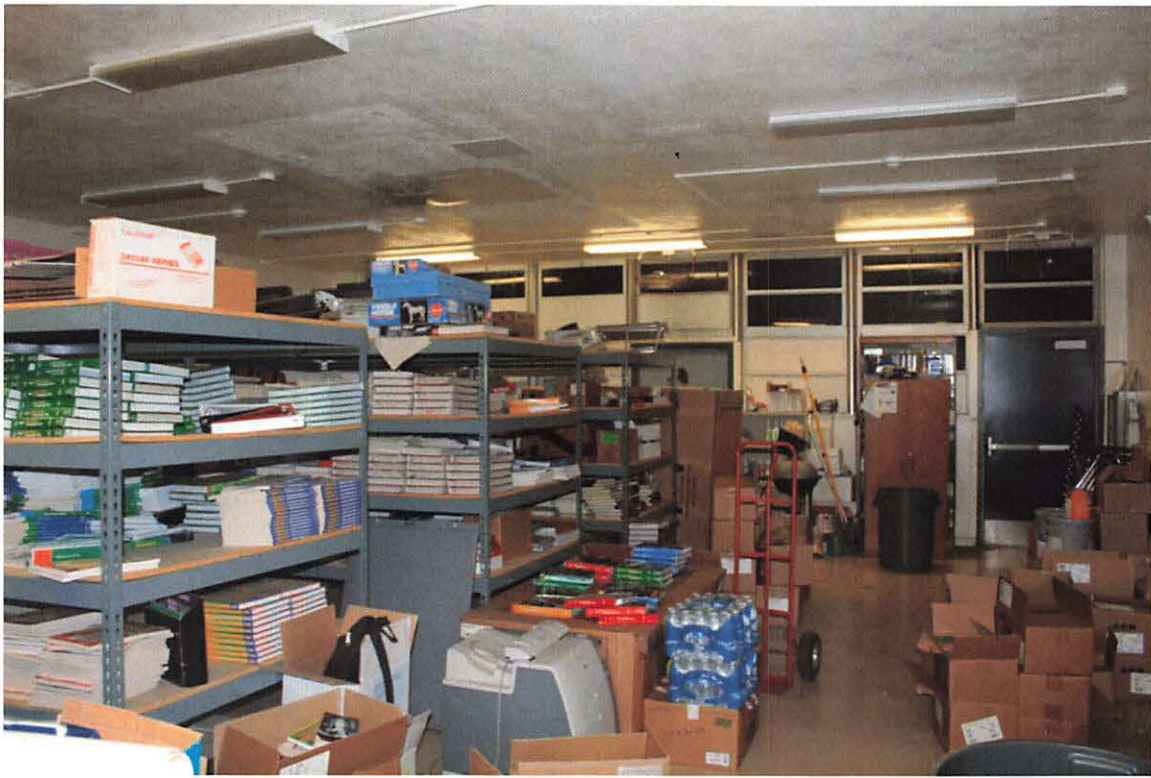
Storage – needs updated storage solutions, finishes outdated

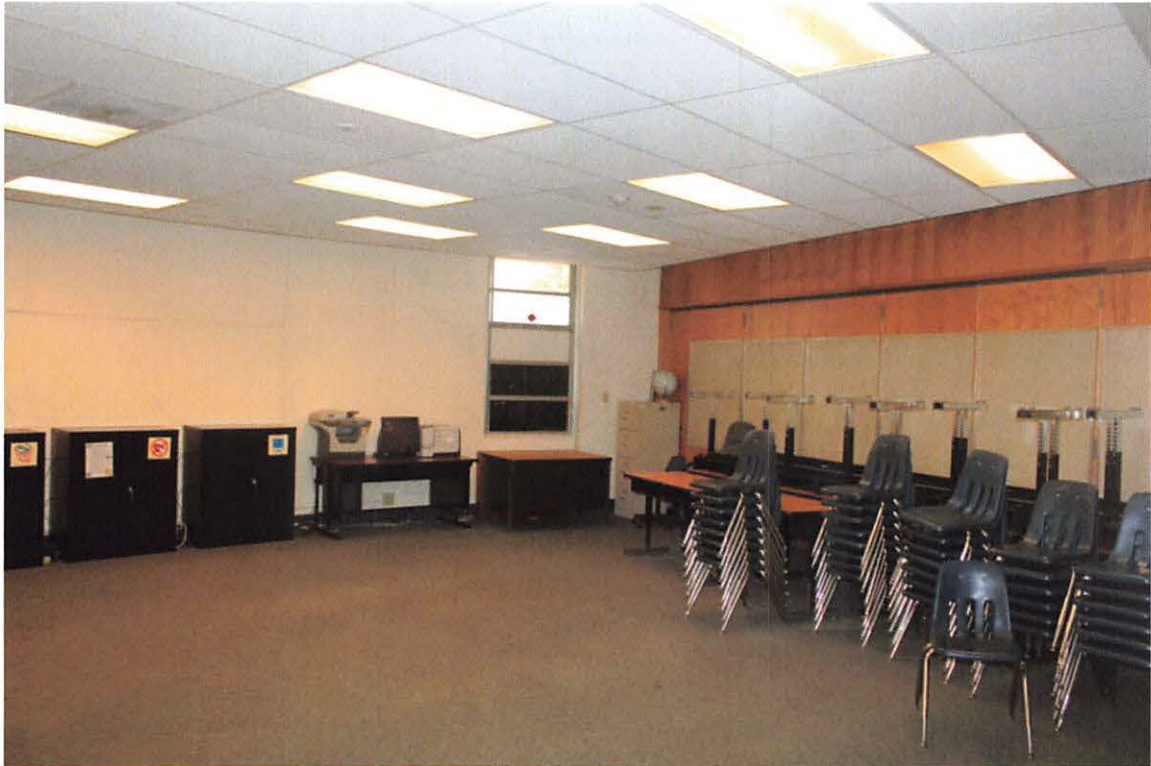
Typical Classroom – finishes outdated, new furniture, storage and casework needed

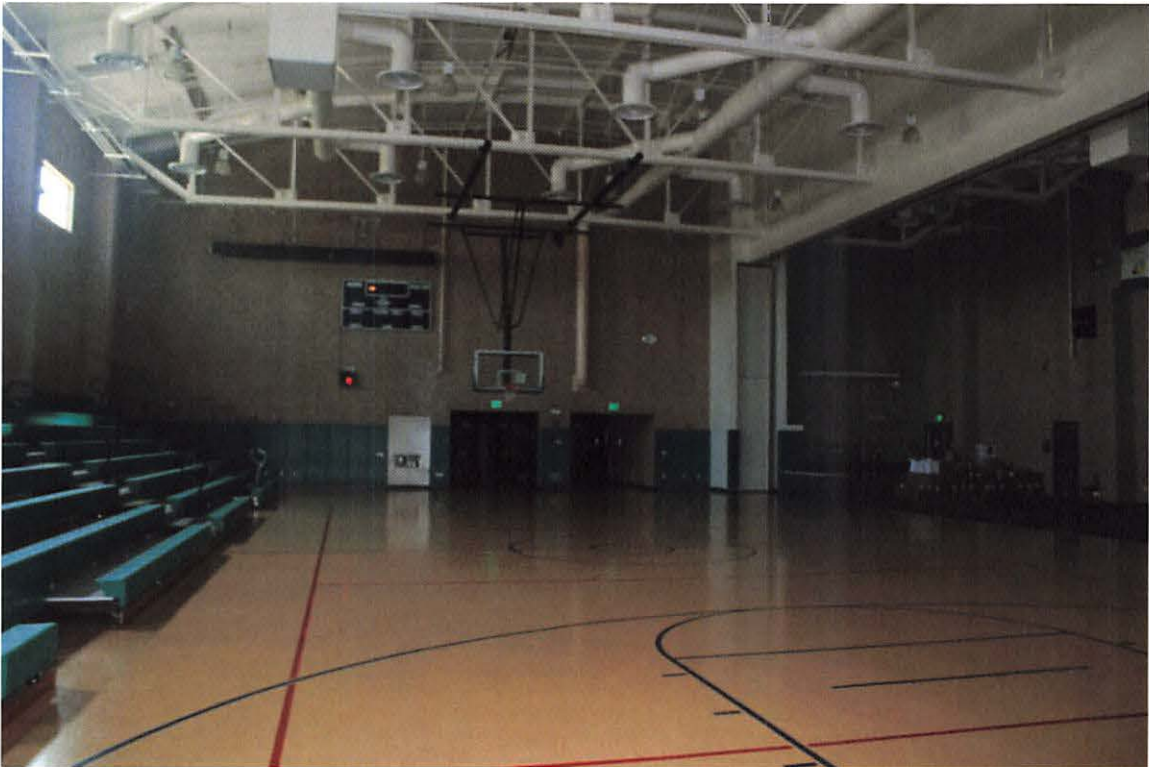
Gymnasium – outdated, needs bleachers, new finishes & more natural lighting

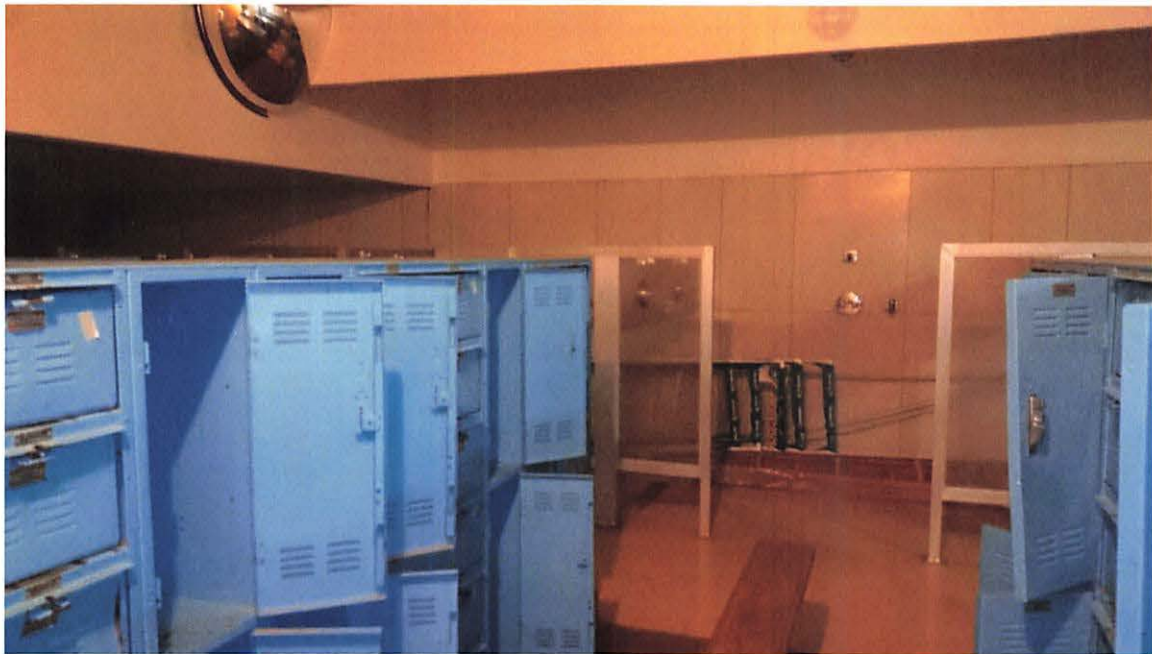
Locker Rooms require renovation

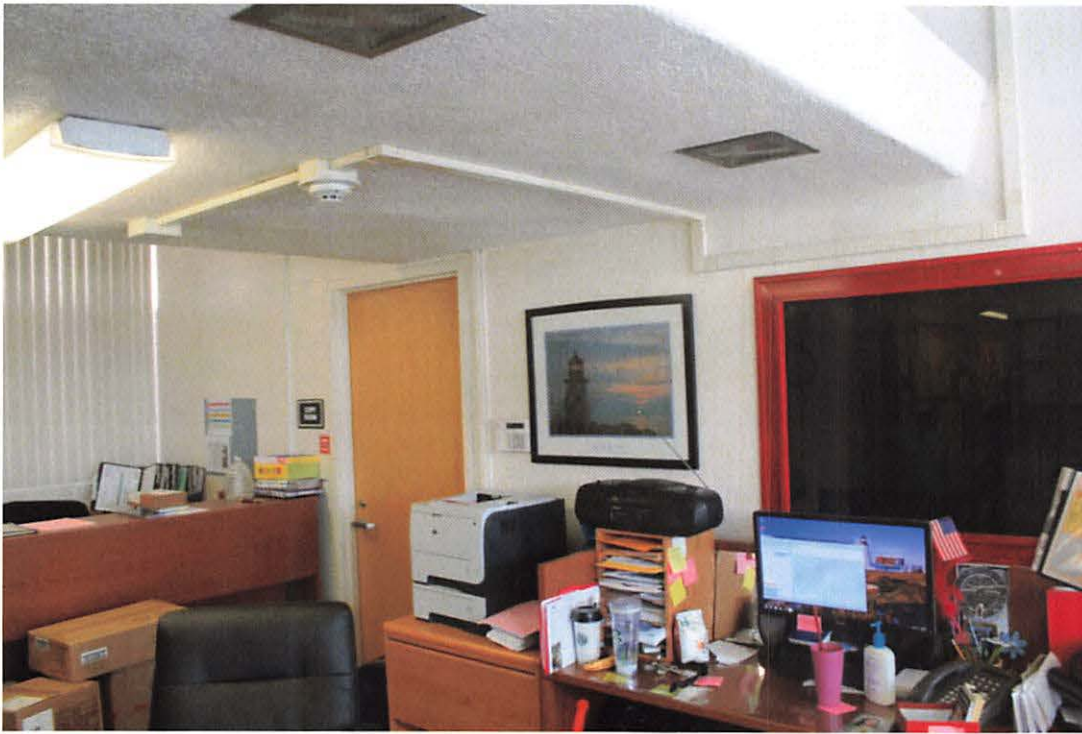
Storage needed in office spaces

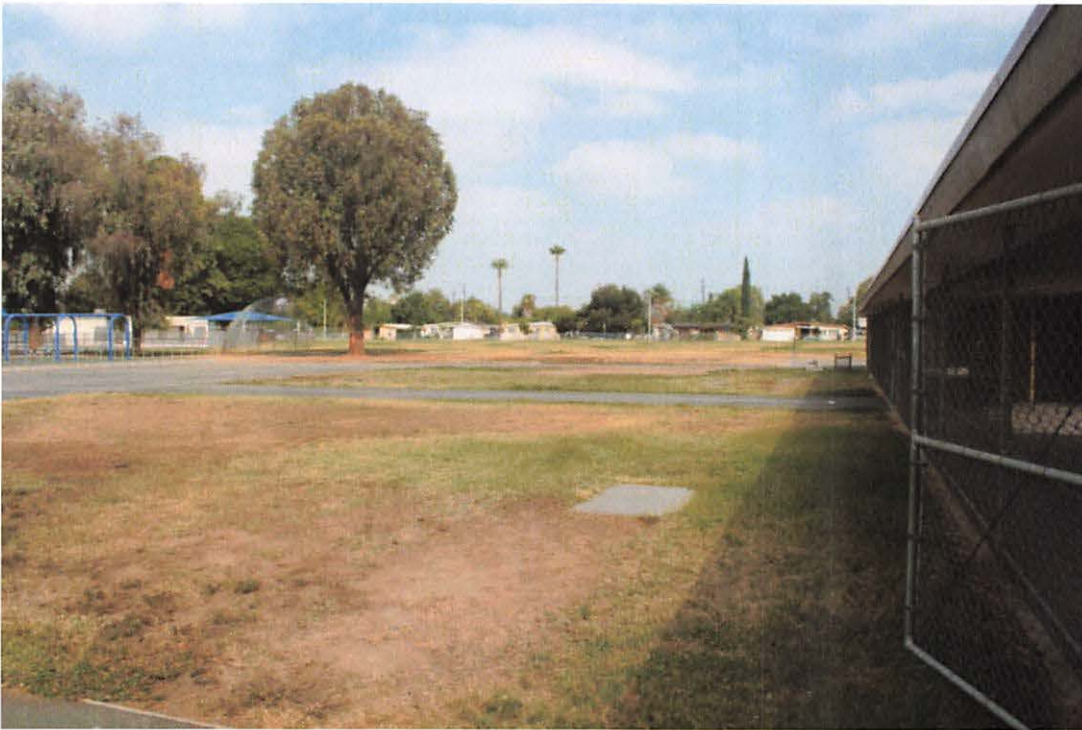
Typical outdoor area – needs re-turfing/outdoor learning commons

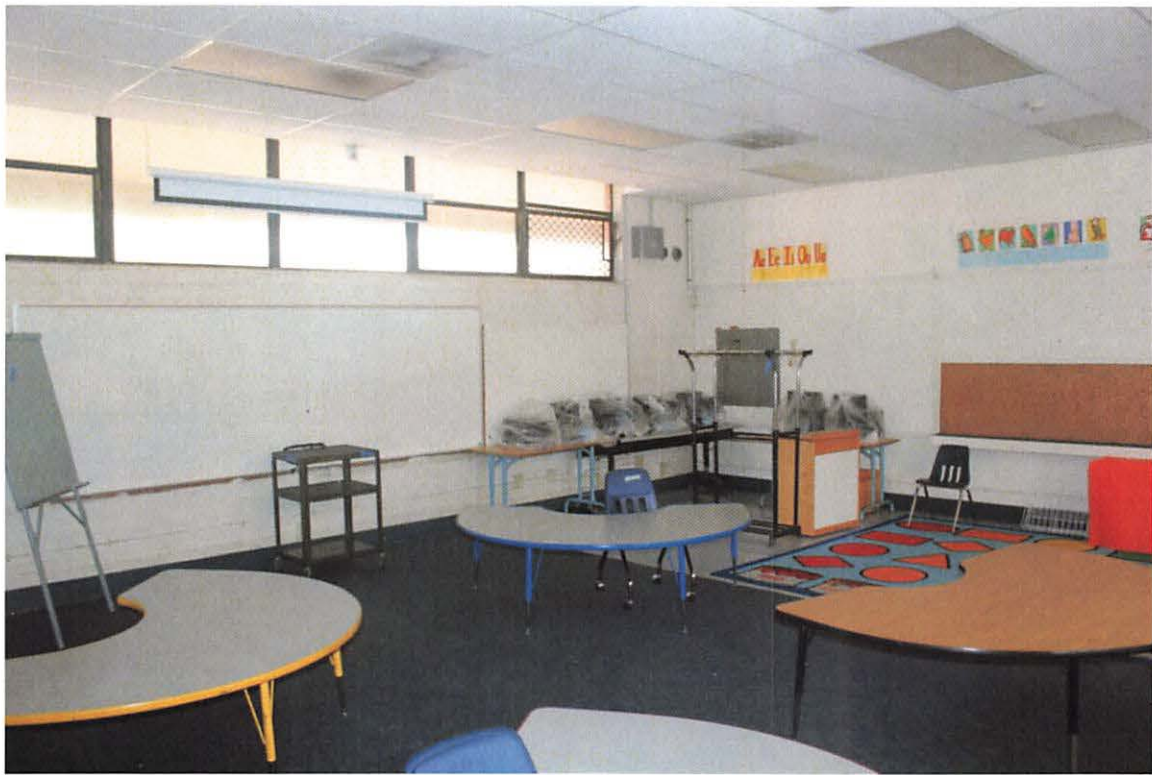
Typical Classroom – finishes & furniture outdated

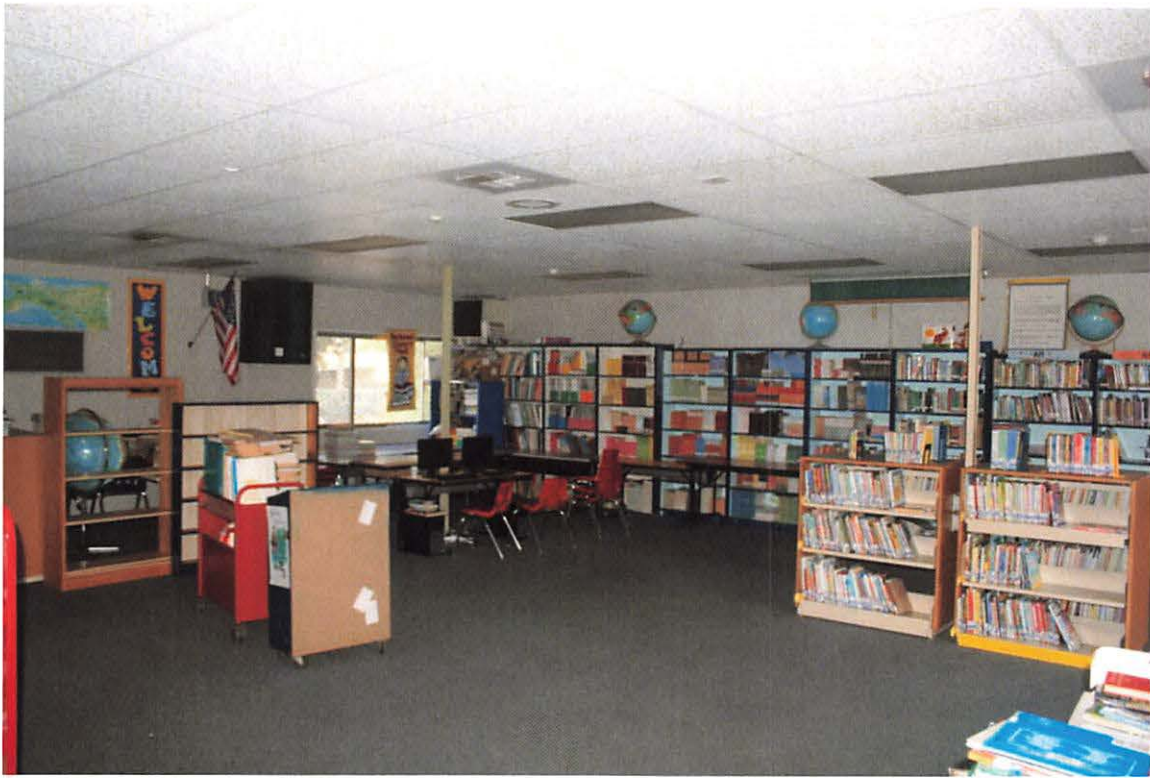
Library – finishes outdated, need storage & casework
