BASSETT UNIFIED SCHOOL DISTRICT

SCHOOL SITE

CONDITIONS ASSESSMENT

Assessment Summary

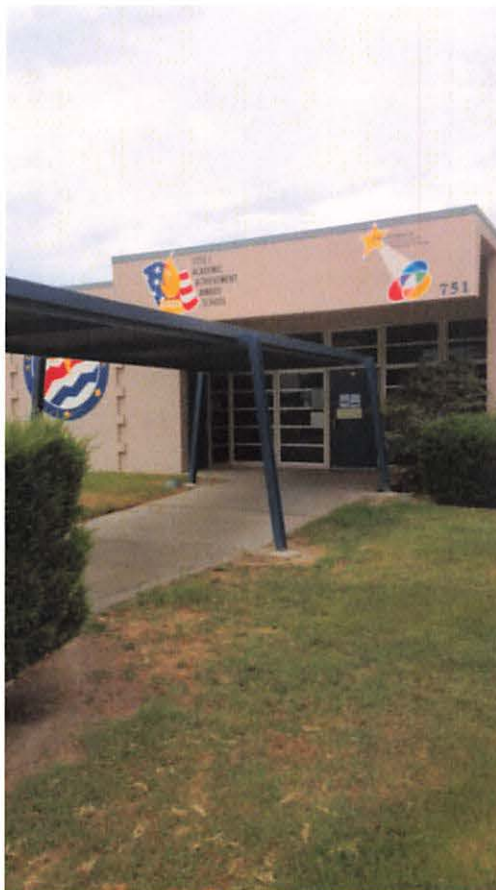
Entry Area needs updating
