BASSETT UNIFIED SCHOOL DISTRICT

SCHOOL SITE

CONDITIONS ASSESSMENT

Assessment Summary

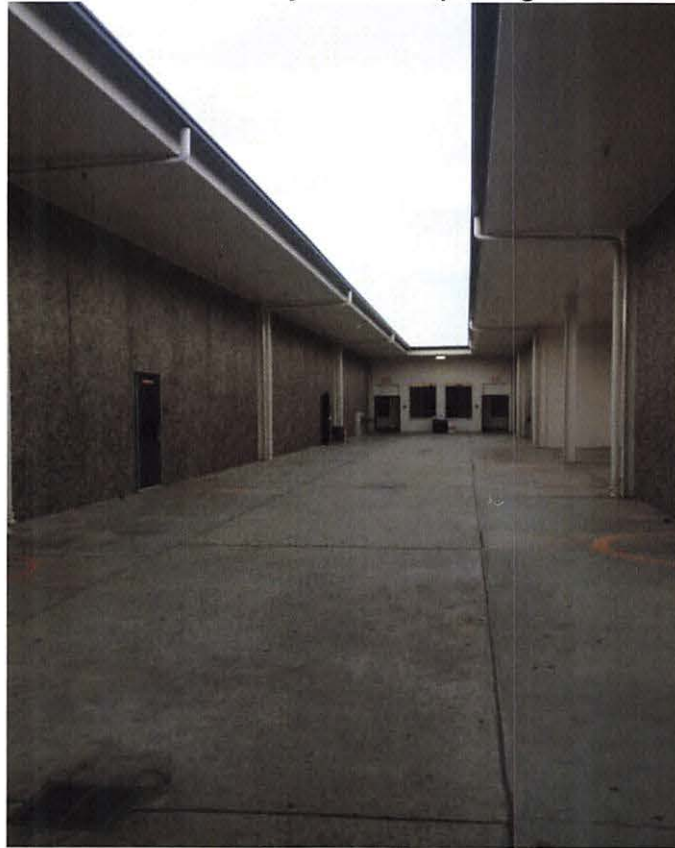
Exterior vestibules are not utilized

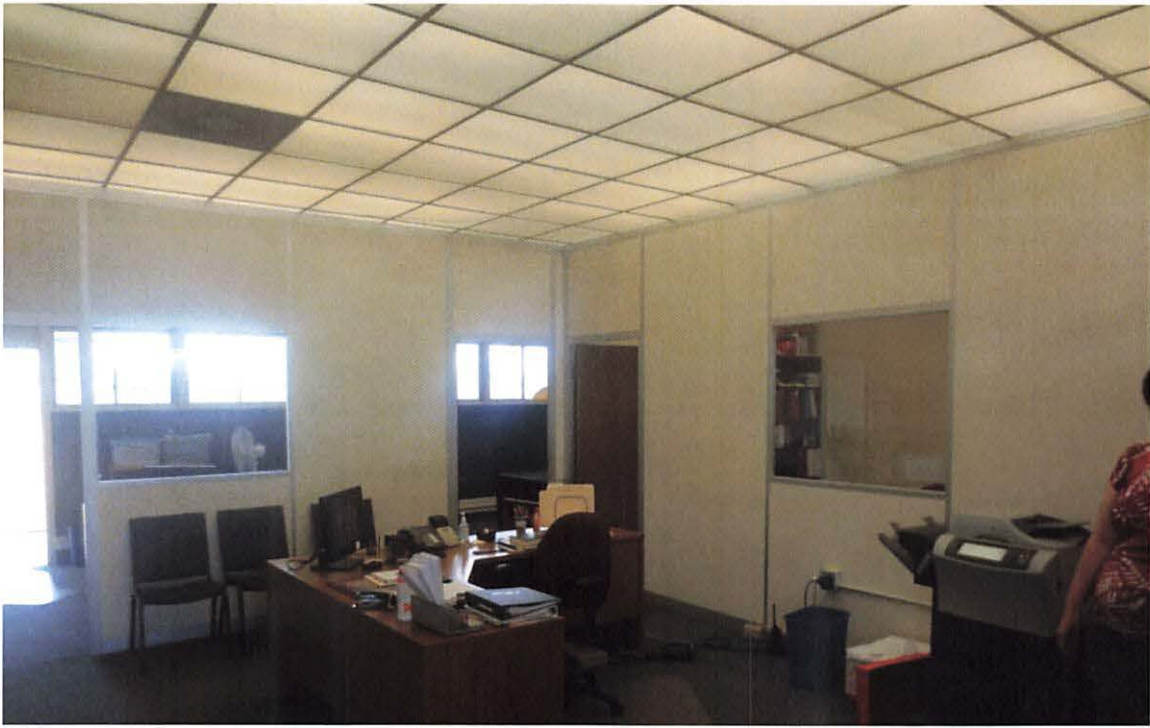
Admin area seems to be recently updated
